WARRANTY RELIABILITY OF CFB BOILER BURNING OIL SHALE

H. SUIK^{(a)*}, T. PIHU^(b)

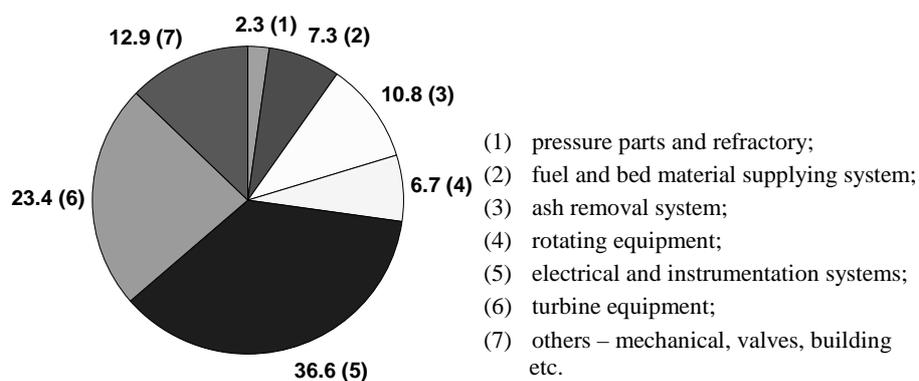
The distribution of defects in Fig. 1 is as follows: 1. Defects concerning boiler – pressure parts and refractory (2.3%). 2. Defects in the fuel and bed material supplying system (7.3%). 3. Defects in the ash removal system (10.8%). 4. Defects in the rotating equipment (6.7%). 5. Defects in electrical and instrumentation systems (36.6%). 6. Defects related to the turbine equipment (23.4%). Similarly, relatively as much defects were found in the turbine in [5]. Other defects are mechanical (valves, building, etc. 12.9%).

Fig. 1. Distribution of defects, %.

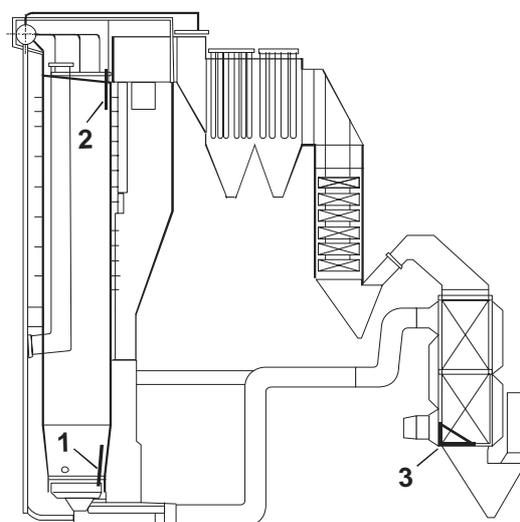
Fig. 2. Scheme of boiler and defective places. 1 – broken canopy, 2 – separator leakages, 3 – damaged air preheater.

Warranty reliability has been affected by low-temperature corrosion of the tubes of the air preheater (position 3 in Fig. 2). Intensive corrosion of the tubes was unexpected because there was no usual aggressive corrosive matter such as sulfur compounds in deposits on the tubes. Obviously intensive corrosion was related to elements such as Cl, Ca, K present in compounds found in deposits.

Replacement of the damaged tubes and improvement of the technology by preheating the air were carried out and implemented during the planned shutdown without the ordered outage, but shutdown time increased by 720 hours, i.e. 9% of the total availability.

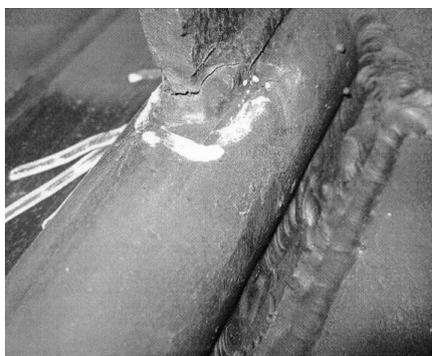
This assumption has been confirmed by the finding that two leakages were discovered in separators of different boilers (Fig. 3). Nonqualified welding between tube and rib on the bent of steam-cooled separator tubes caused developing a crack penetrating tube walls. Annual availability of the boiler was affected due to failures at which outage times for remedy works varied from 72 to 96 hours, approximately 0.45–0.6% of the total availability decreasing warranty reliability.

Fig. 3. Penetrating crack on tube walls (position 2, Fig. 2).

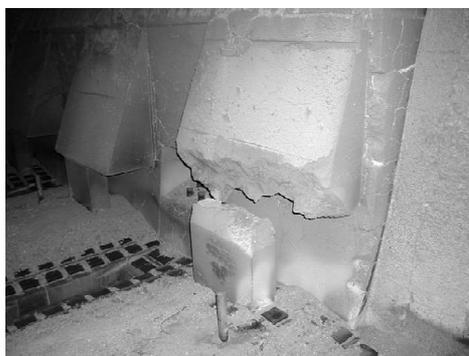
Another kind of failures occurred in the furnace of boilers. On the contrary [5], when burning oil shale, damages in the refractory of steam-cooled separators were not noticed. Boiler operation had no destructive influence on the refractory of the walls, wing walls and return legs inside of the bed material, but there were cracks in the refractory canopies of solids' return channels, obviously, thermal expansion of the refractory of the furnace bottom and of the back wall being different. The upper parts of some canopies were disintegrated due to moving of the canopies' refractory (Fig. 4). Repairs or casting of new canopies were made during the planned shutdown without the ordered outage of boiler.

Fig. 4. Disintegrated refractory of canopy (position 1, Fig. 2).

Strengthened ties between the canopy and the back wall avoided the following disintegration of refractory.

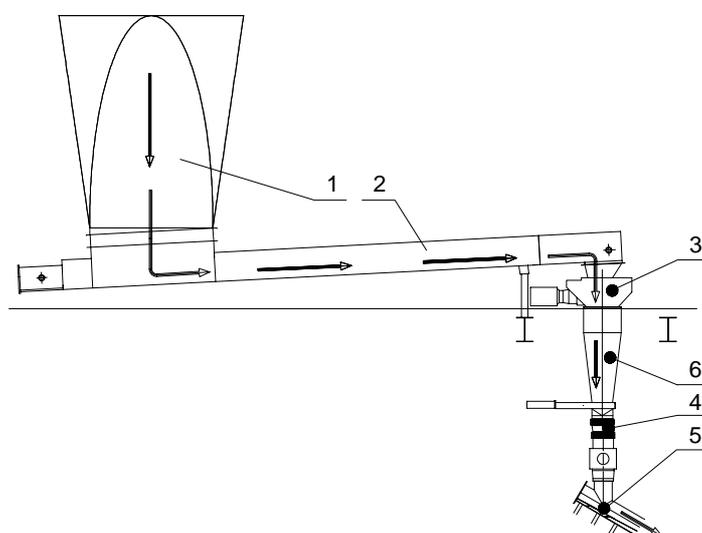
Fig. 5. Fuel supplying system. 1 – bunker of fuel, 2 – conveyor, 3 – crusher, 4 – compensator, 5 – inclined chute, 6 – vertical canal.

In these systems the damages have been resulted from wearing the elements due to moving of the erosive matter in the fuel system (positions 4, 5 and 6 in Fig. 5).

Discs of the secondary crusher (3) have broken due to the presence of foreign metallic substances in the fuel flow. This had happened irregularly, but averagely once in month. If one crusher is stopped for the replacement of broken discs, fuel flow is distributed between the remained three crushers. Failure of that kind and proper action – replacement of the discs – has not required any forced outage of the boiler.

Erosive wear of the corrugated wall with thickness 2 mm (4) was avoided by correction of the construction, but erosive wear of the inclined elements (6) after 2000–3000 hours and (5) after less than 8000 hours were regular due to abrasive action of fuel flow. Such a wear is characteristic of such kind of fuel transportation in the case of the present combustion mode.

Damages in slightly inclined walls were eliminated during the operation without boiler outage, because the damages marked at (6) occurred in one line of the set of eight for one boiler.

Damages on fuel chutes (5) were repaired during boiler shutdown – once a year. As shutdown of the boiler has taken place every year, the ordered outages of boiler are made twice during the warranty period.

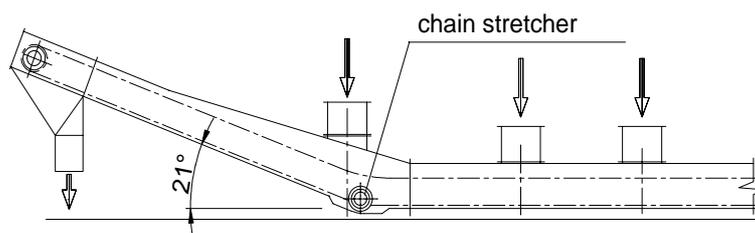
Fig. 6. Bottom ash conveyor.

Failures of other kinds occurred in the non-cooled chain stretcher (Fig. 6) which stretches the chain to turn at an angle of 159°. The stretcher consists of the shaft, bearings and the tail wheel. Working conditions of the stretcher were complicated as high temperature of ash and sometimes overload of scraper caused the breakdown of the assembly. There were damages of bearings, intermediate bushings and packing housing, and the damages of shaft. The lifetime of the assembly changed from 5040 to 13 600 hours – in average from one to two years.

Replacement of the stretcher assembly did not necessitate outage of the boiler, only shutdown of the failing conveyor. During improvement of the stretcher by strengthening the construction, ash unloading from the furnace was carried out by the second ash conveyor, and it was recommended to decrease boiler load by 10–15%.
