CRACK IN RECOVERY BOILER

H. SUIK

Tallinn Technical University
Thermal Engineering Department
Tallinn, Estonia

Recovery boiler "Mitsubishi-315" erected at the end 1964 has worked more than 240,000 hours.

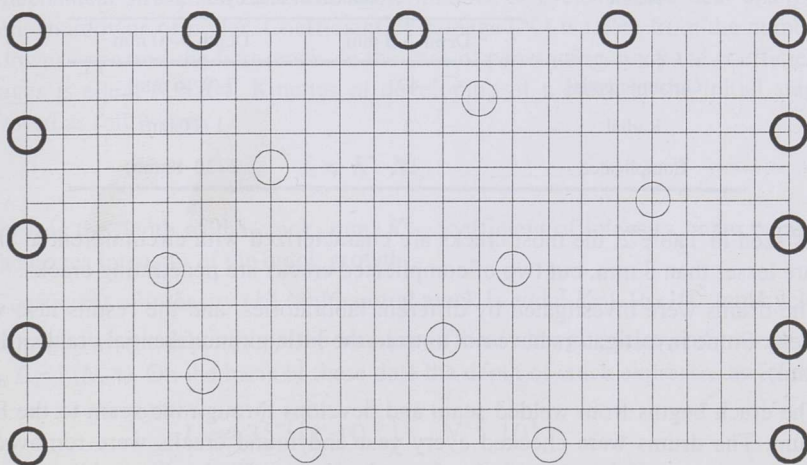
The bank tubes were rolled in the drums, and besides that the tube ends in ligaments of the border rows at the three sides (Fig. 1, bold line) were welded too.

Figure 1. Layout of bank tubes plate in steam and water drums. Front of boiler; bold line shows welded rolled eyes

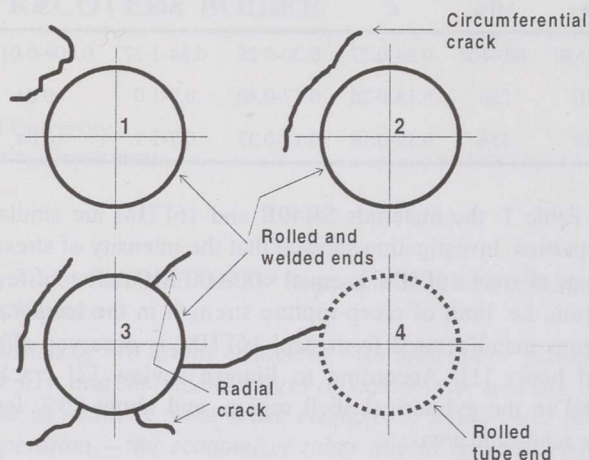
The first cracks in these welded eyes were observed after 20 years' operation, about 160 000 h and after 220-240 shutdowns. Most of formed cracks had been aligned in two directions: radial and circumferential of tube holes. Some cracks had more complicated shape. Cracks with different shapes are represented in Figure 2.

Figure 2. Cracks with different shape

Tube eyes No-s. 2 and 3 have circumferential cracks. Tube eye No. 1 has crack with complicated shape. Tube eye No. 3 has the both type cracks – radial and circumferential. After 232,000 hours' operation, the radial crack began from eye No. 3 and penetrated through ligament between eyes No-s. 3 and 4. In the Table 2 parameters of cracks are given which are observed in 92 tube eyes.

The crack begins from welded seam and develops through the seam to the body of drum. The drums were checked every year and found cracks were removed by sharpening on a grindstone and the formed pit was filled with welding. It was observed by checking that with aging of metal the number of formed cracks continu-

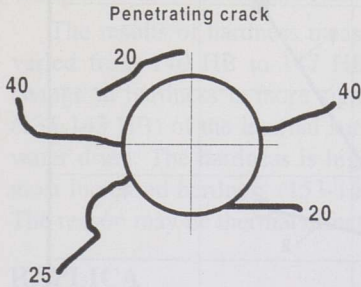
Figure 3. Penetrating cracks in water drum. Numbers show the depth of crack

The first crack in tube eyes presented in Figure 3 was observed after 176,000 hours' operation. The measured depth of crack was 5 mm. Checking after 32,000 hours, the depths of cracks were 7 and 8 mm, and after extra 8000 hours (totally 216,000 hours) the depth of cracks was increased to 12 mm, and for 232,000 h operation some cracks run through the wall (40 mm) of water drum.

Presumably the developing of through crack was the following: the first crack with depth 5 mm, observed after 176,000 h was not sharpened with a grindstone to peak of crack and the crack continued to penetrate deeper. So this process repeated every year, and after 232,000 hours' operation the crack run through the wall of drum.

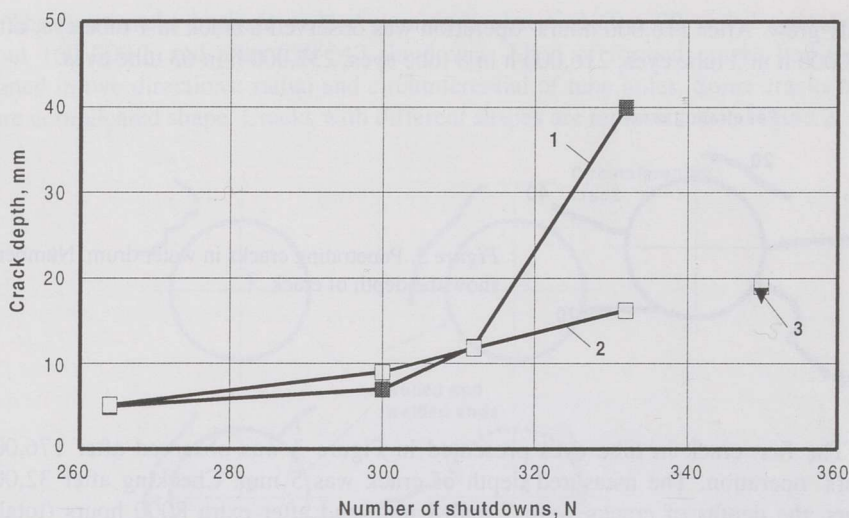
Figure 4. Development of penetrating crack. 1 - current crack, 2 - calculated crack, 3 - single crack formed during one year after 240,000 hours' operation

As seen in Figure 4, the calculated crack depth (line 2) corresponds to the current depth at the first stage of the crack forming. Obviously these cracks are formed and developed due to thermal fatigue. Marked labels on line 1 are showing measured depth of penetrating crack according to the number of shutdowns. Label 3 marks the depth of crack which forms during one year after 240,000 hours' operation.

Point 3 in Figure 4 shows the depth of a crack formed in boiler drum during one year after 232,000 h operation and 336 shutdowns, i.e. the crack formed after these conditions. After that, boiler worked extra 8000 hours and had 14 shutdowns.

Calculated by the equation (2) under conditions $\tau = 240,000$ h and $N = 350$ shutdowns depth is equal to 19.06 mm. As seen in Figure 4, the difference between depth of actual crack (18 mm) and calculated value (19.06 mm) is equal to 1.06 mm.

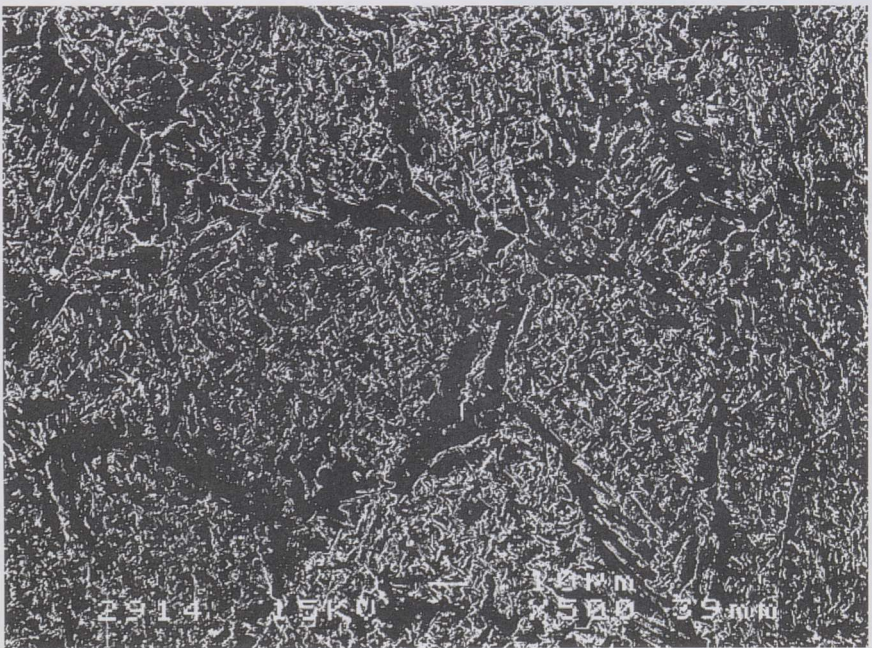
The microstructure in a replica is shown in Figure 5. As seen, it is mainly acicular ferrite or bainite with network of ferrite at the grain boundaries of prior austenite. Acicular ferrite and bainite likely was the base metal of drum. Only bainite structure characterizes transient zone or weld.

Examining the Figure 5, it may be noted that the phenomena of structure changes during the boiler operation are not observed.

Figure 5. Microstructure of sample on the internal side of drum. Magnification 500 times
