CRITERIA OF REPAIRING TUBE SURFACE DAMAGES BY OVERLAY WELDING

H. SUIK

Horizon Pulp and Paper Ltd
10 Anija St., Kehra 74305, Estonia

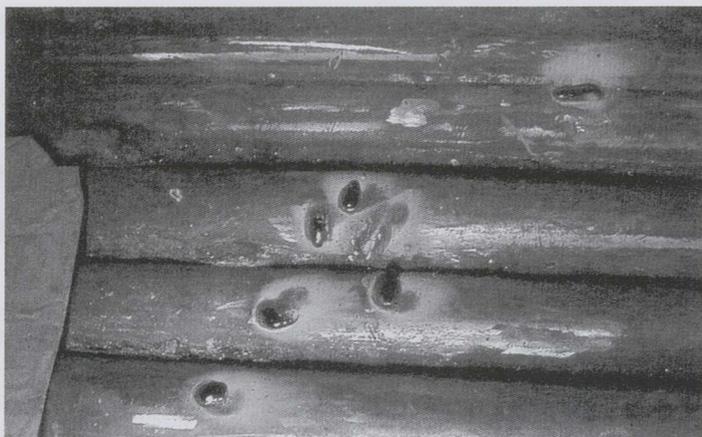
Fig. 1. Mechanical damages on the tubes

damages are transversal or longitudinal ditches made by pneumatic hammer lance into the outer surface. Longer pits were 25–45 mm long. The shape of the damage was, to some extent, dependent on the form of lance.

The damages caused by lance with pointed end had distinct boundaries with sharp edges overlapped on the outer surface of tubes. A lance with blunted end bruised the tube wall forming a bulge inwards the tube wall, but did not extend through it. The maximum depth was 3–5 mm from the edges of the damages; the minimum depth could be only the trace.

The damages were located on the tubes chaotically, on some tubes there were none, on the other ones there were many, whereby the minimum distance between two damages in that case was about 8–10 mm.

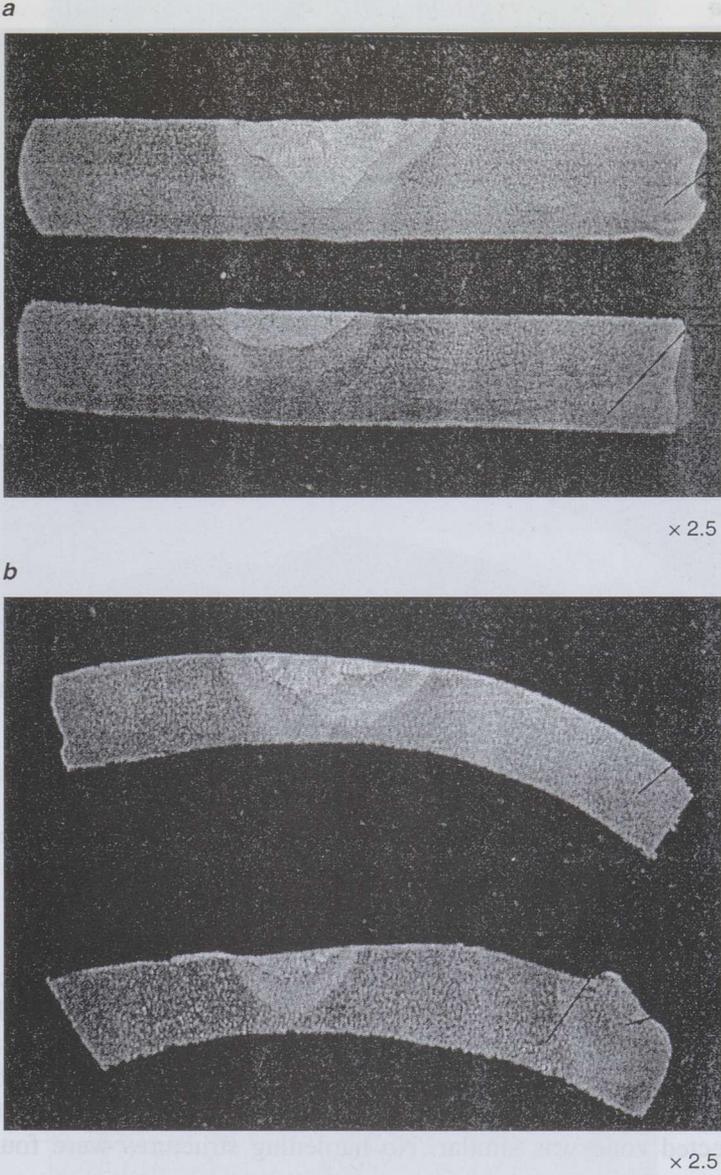
Macrostructure study of the test tubes (Fig. 2a,b) and of the furnace bottom tube (Fig. 3a) after overlay welding revealed that the passes were free from defects. On the furnace bottom tube, only a slightly extending bulge with the diameter of 10–12 mm was noticeable on the inner wall opposite the passes. The passes consist of three passes in succession. The maximum depth of the damage was 2.3 mm, and the thickness of the tube wall was between 4.3 and 4.5 mm. The length of the damage extended up to 19 mm.

Fig. 2. Macrosection of test tubes after overlay welding:
a – test tubes N3 (wall thickness in the place of welding 6.4 mm; pass depth 4.8 mm) and N2 (6.2 and 2.2 mm, respectively);
b – test tubes O3 (wall thickness in the place of welding 4.0 mm; pass depth 1.6 mm) and O2 (3.5 and 1.1 mm, respectively)

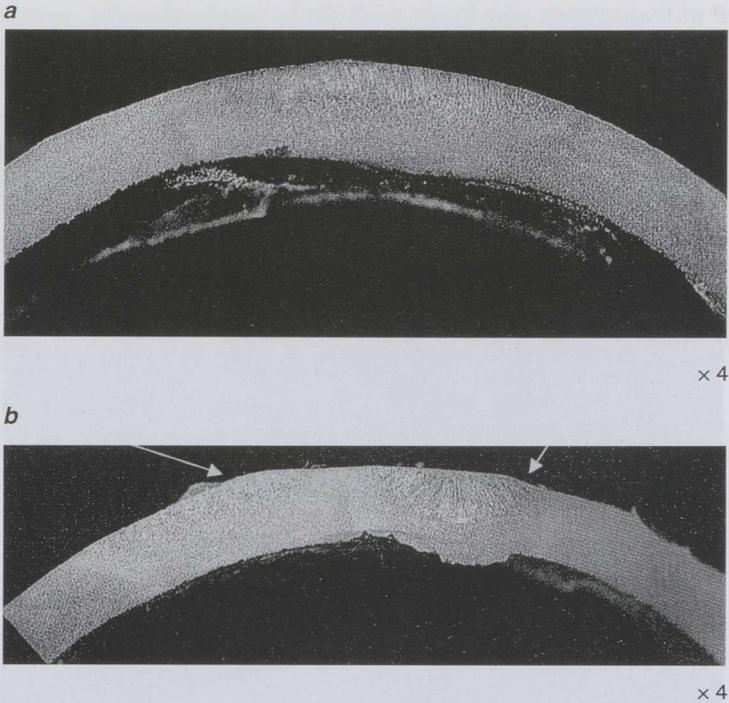
The situation on the place of the bottom tube, where the thickness of the wall was 4 mm and the depth of the damage 3.0 mm (Fig. 3b), was different. One can see a bulge with the height of 1 mm, deeply protruding from the tube inner wall. The heat-affected zone is easily observable.

Fig. 3. Macrosection of furnace bottom tubes after overlay welding:
a – tube wall thickness in the place of welding 4.3–4.5 mm; pass depth 2.3 mm, length 19 mm);
b – tube wall thickness in the place of welding 4.0 mm; bulge thickness 1 mm; pass depth 3 mm

1. Mechanically caused damages on the tube surface are repairable by welding if the following requirements are taken in account:
 - the wall thickness around the damage has to be more than 3 mm
 - the wall thickness at the bottom of the damage has to be more than 2 mm
 - the diameter of the welding electrode has to be not more than 2-2.5 mm and welding must be done using weak welding current
 - after welding, every welding pass has to be cooled slowly to avoid hardening of the structure
2. Repairing the mechanically caused surface damages by overlay welding in accordance with the above-mentioned requirements, will leave the mechanical properties and microstructure of steel unaltered.

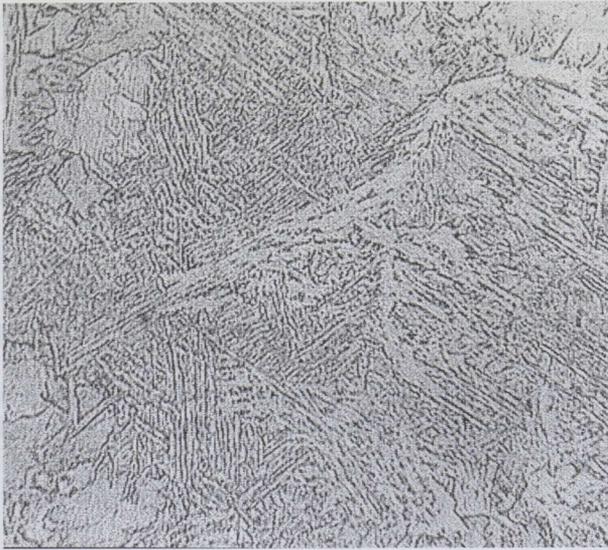
× 500

Fig. 4. Macrosection of metal on the bulge. Microstructure – large-grain martensite

The microstructure of the base metal of the furnace tube did not differ from the microstructure of the test tubes. The differences in the microstructure of steel appeared in the form of extended bulges. Complete recrystallization of the structure had taken place in the extended bulge (Fig. 4) as a result of overheating – its microstructure was large-grain martensite. Overheating during the welding process and the following quick cooling caused large changes in the structure of the furnace tubes.

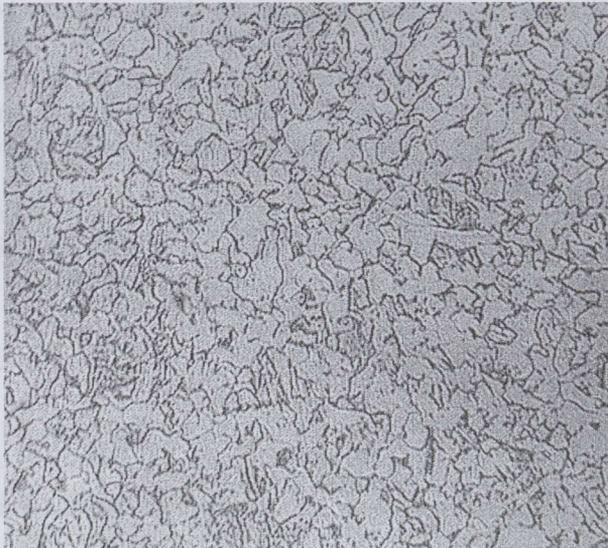
× 500

Fig. 5. Macrosection of heat-affected zone. Microstructure – partial recrystallization to the large-grain Widmannstannen structure

Figure 5 shows that partial recrystallization had occurred in the small bulge, structure of the steel was similar to the structure in the fusion line of the overfusion metal and base metal demonstrating the large-grain Widmannstatten structure.
