Oil Shale, Vol. 14, No. 3 Special pp. 328-334

CRACK IN RECOVERY BOILER

Recovery boiler "Mitsubishi-315" erected at the end 1964 has worked more than 240,000 hours.

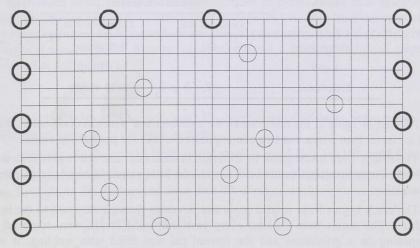
The bank tubes were rolled in the drums, and besides that the tube ends in ligaments of the border rows at the three sides (Fig. 1, bold line) were welded too.

Figure 1. Layout of bank tubes plate in steam and water drums. Front of boiler; bold line shows welded rolled eyes

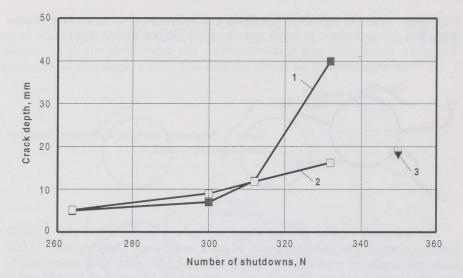
Figure 4. Development of penetrating crack. 1 - current crack, 2 - calculated crack, 3 - single crack formed during one year after 240,000 hours' operation

As seen in Figure 4, the calculated crack depth (line 2) corresponds to the current depth at the first stage of the crack forming. Obviously these cracks are formed and developed due to thermal fatigue. Marked labels on line 1 are showing measured depth of penetrating crack according to the number of shutdowns. Label 3 marks the depth of crack which forms during one year after 240,000 hours' operation.

During some time depending on the cycles of shutdown and operation time, the mechanical stress exceeded the thermal stress, and crack developed due to mechanical fatigue. At this stage the intensity of crack growth induced by mechanical fatigue is much more than the intensity induced by thermal fatigue.

Minimum required thickness of shell plate of drum is 26.56 mm, and it was actually taken equal to 29 mm. At the same time the calculated thickness of tube plate in drum equals to 44.25 mm, actually and it was determined equal to 46 mm. It is seen that if the depth of crack in the ligament equals to more than 46-26.65=19.35 mm then residual thickness of plate is less than required minimum thickness. Obviously it is time of increasing the intensity of crack developing due to mechanical stress. It is shown by the current data (Fig. 4, the upper part of line 1) as well.

Point 3 in Figure 4 shows the depth of a crack formed in boiler drum during one year after 232,000 h operation and 336 shutdowns, i.e. the crack formed after these conditions. After that, boiler worked extra 8000 hours and had 14 shutdowns.

Calculated by the equation (2) under conditions τ =240,000 h and N=350 shutdowns depth is equal to 19.06 mm. As seen in Figure 4, the difference between depth of actual crack (18 mm) and calculated value (19.06 mm) is equal to 1.06 mm.

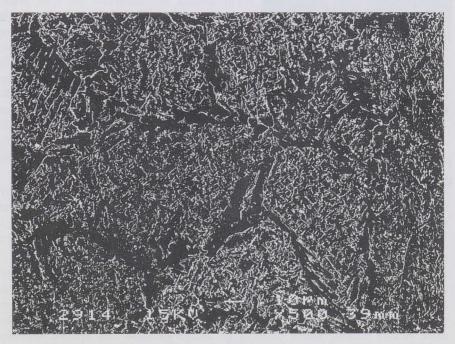
The microstructure in a replica is shown in Figure 5. As seen, it is mainly acicular ferrite or bainite with network of ferrite at the grain boundaries of prior austenite. Acicular ferrite and bainite likely was the base metal of drum. Only bainite structure characterizes transient zone or weld.

Examining the Figure 5, it may be noted that the phenomena of structure changes during the boiler operation are not observed.

Figure 5. Microstructure of sample on the internal side of drum. Magnification 500 times
