Coastal processes in the Eastern Gulf of Finland – possible driving forces and the connection with nearshore development

Abstract. The coastal zone of the Eastern Gulf of Finland is actively changed under the influence of complicated natural and anthropogenic factors. The easternmost part of the gulf, a valuable area for recreation, is characterized by very intense coastal processes and is dominated by erosion. Analysis of historical materials, archive aerial photographs and modern high-resolution satellite images together with on-land investigations have shown that the majority of the coast of the easternmost part of the gulf is being eroded and is retreating. A study in the nearshore (side-scan sonar profiling, accompanied by echo-sounding and sediment sampling) enabled the main geological reasons for the coastal erosion to be established.

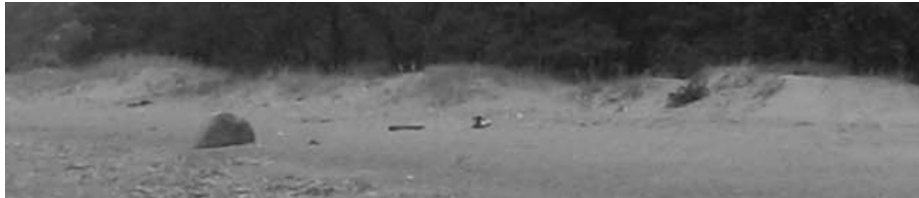
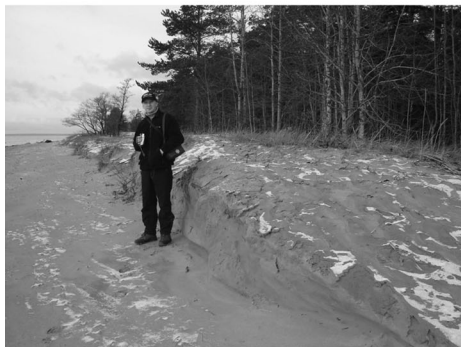
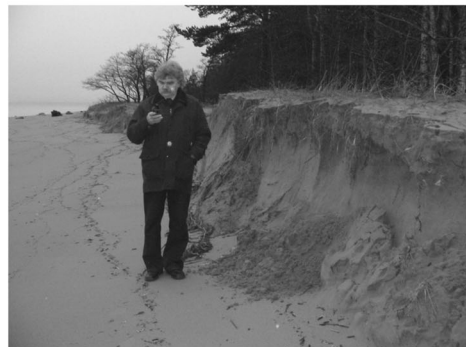
Fig. 7. Erosion of the foredune after autumn and winter storms accompanied by a sea-level rise in Komarovo Nature Reserve: (a) June 26, 2006; (b) October 24, 2006; (c) January 11, 2007.

Field monitoring and observations from 2004 to 2007 have shown that the erosion processes have an intermittent, step-like nature. Periods of rapid, drastic changes are separated by much longer periods of stability. The most significant damage to sandy beaches and erosion of the dune system in last decade was observed during autumn and winter storms of 2006–2007 (Fig. 7).
