Rivo Bernotas

NEW INSIGHTS ON THE CHANGES OF TOWNSCAPE IN 14TH-CENTURY TARTU

In this article I will discuss some of the changes in the townscape of Tartu in the 14th century and analyze how these changes could have been related to the re-planning of the town area. The topics examined in this article cover the medieval waste management, the erection of stone buildings, the existence and purpose of the defences in the riverside part of the town, and the workers behind all the construction activities in Tartu. The present research suggests that the disposal of waste was regulated by the town laws which were valid only within the limits of the town area, enclosed by town wall, and therefore did not apply to the suburbs. In earlier studies, the introduction of brick buildings to Tartu has been dated from the end of the 14th century to the 15th century. Based on new information, the introduction of brick buildings can be traced to the early 14th century. It can be suggested that the town was ready for extensive planning and erection of walls only after the urban community was populous enough to carry these works out as these activities needed a large number of local workers. The recent

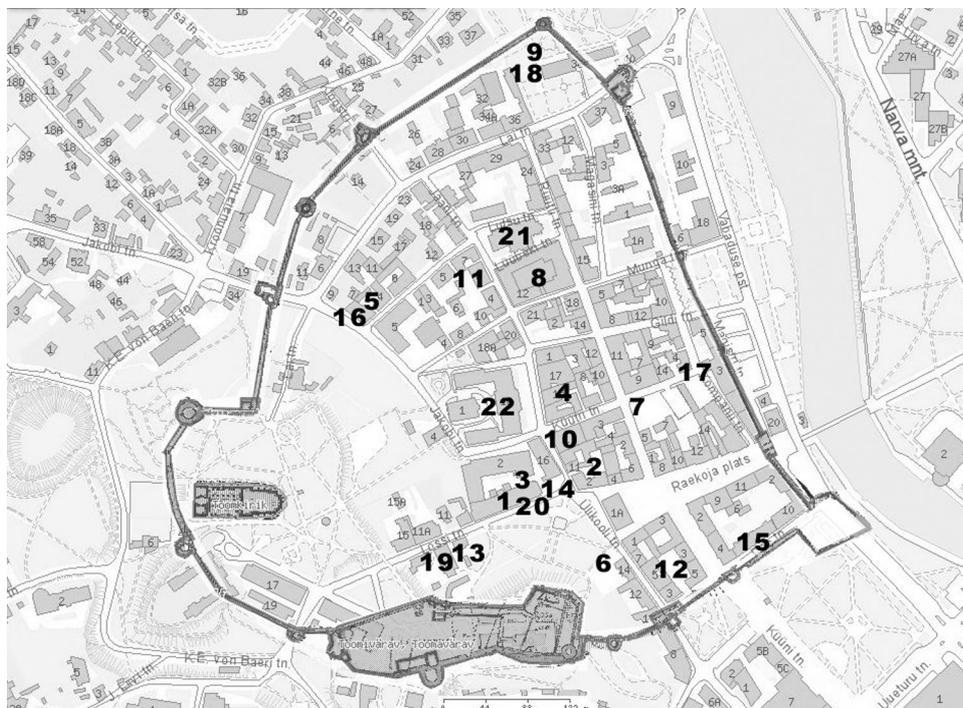
Fig. 1. Map from the Town Government of Tartu. The location of the objects mentioned in the article. Cesspits: 1 Lossi Street 3 (Mäesalu 1990), 2 Raekoja plats 2 / Ülikooli St. 11 (VII Quarter) (Vissak 1994; Aun 1998), 3 Courtyard of Lossi 3 / Jakobi 2 (Tvauri 2011), 4 Ülikooli Street 15 (Bernotas 2008), 5 Lutsu Street 2 (Kriiska et al. 2011), 6 Ülikooli Street 14 (Bernotas 2008), 7 Küütri St. 5 (Aus 1993; Piirits 1994), 8 Courtyard of Munga St. 12 (Piirits 1998; 2000; Vissak 2000b), 9 Lai St. 38/40 (Mäesalu 2004; Bernotas 2006), 10 Küütri Street 1 (Tvauri & Bernotas 2007), 11 Jaani Street 8 (Tvauri 2004), 12 Küüni Street 3/5 (Tvauri 2003), 13 Lossi Street 24 (Trummal 1992), 14 Corner of Lossi-Ülikooli Streets (Metsallik 1995), 15 Poe Street (Tvauri & Bernotas 2007). Medieval stone houses: 16 Lutsu Street 2 (Kriiska et al. 2011), 17 Kompanii Street (Lange 1994), 18 Botanical Gardens (Trummal 1992; Russow et al. 2006), 19 Lossi Street 24 (Trummal 1992), 20 northern side of Lossi Street (Metsallik 1987). Churches: 21 St. John's Church (Läanelaid 2002), 22 St. Mary's Church (Altoa 2009).

The distribution area of the cesspits discovered in Tartu (Fig. 1) clearly shows that their usual location is inside the town quarters, in the territory enclosed by the town wall.³ Therefore, it can be assumed that they were located in the

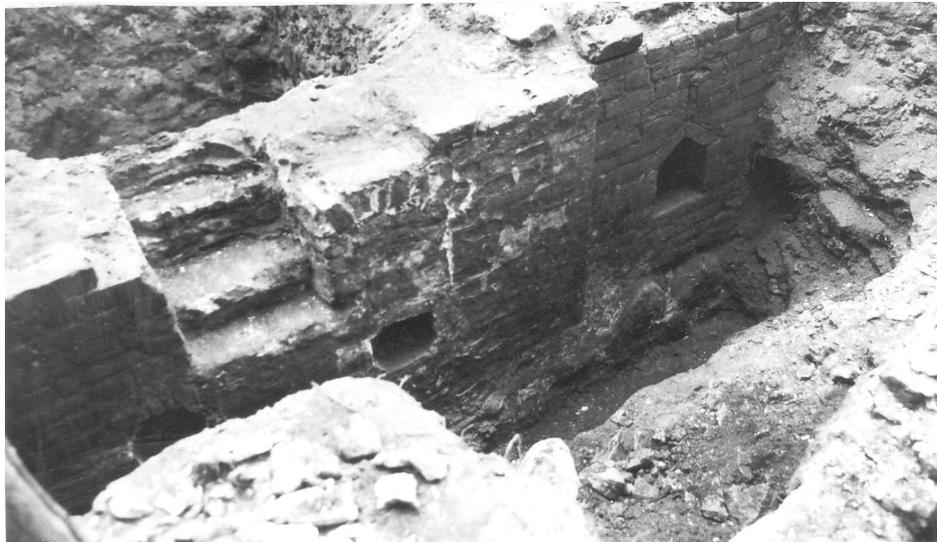
Fig. 2. Interior wall of the medieval stone building in Lossi Street (Metsallik 1987, fig. 2). Photo by Romeo Metsallik.

oldest examples of stone buildings are a one-room brick building in Kompanii Street from the 13th–14th century (Lange 1994) and house remains from Lossi Street. The walls of the last-mentioned brick house were stacked on top of the fieldstone foundation. This building has been dated to the 14th–16th century (Trummal 1992, 8).
