Chapter 1

**BUILDING REMAINS AT THE HILL FORT
OF KEAVA**

Valter Lang

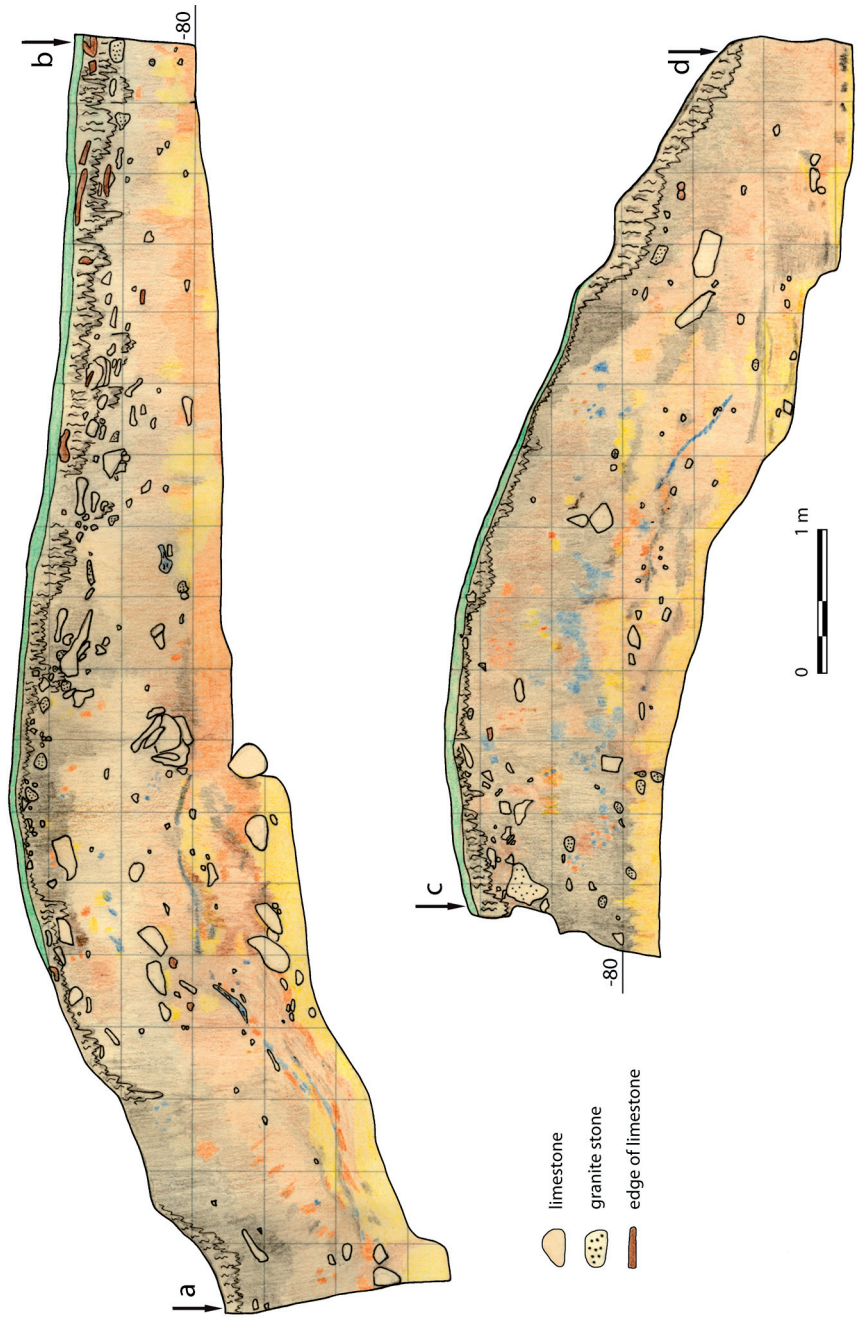
Fig. 1.2. Profile of the side rampart in excavation area I. Drawing by Sijja Kalle and Riina Vesi.

The profile of the rampart, the final cleaning of which was completed at the end of the excavations during the third season, clearly demonstrated that there had been at least four, but most likely even five fortification phases on the hill (Fig. 1.2). Here I will analyze these phases in the sequence in which they were uncovered in the course of the excavations, i.e. starting from the last (the fifth and fourth) and ending with the first phase.

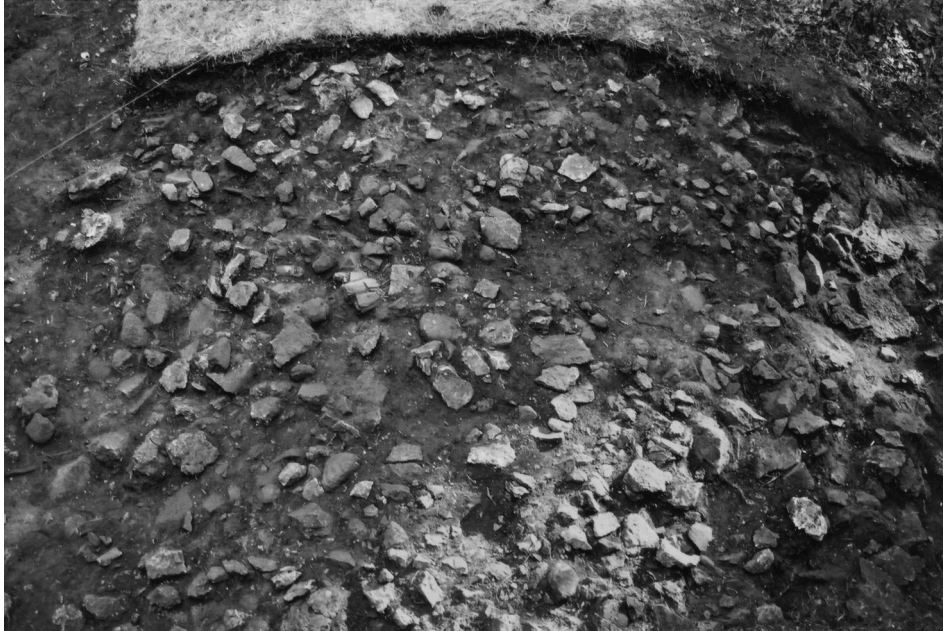
Fig. 1.3. The top-most layer on the rampart. Photo by Valter Lang.

After the removal of turf and the uppermost humus layer, we observed that the rampart of the hill fort was covered with a layer of stones, mostly medium-sized limestone slabs (Fig. 1.3). No order was discovered in the location of these stones; as they all bore clear traces of burning, one may conclude that (the last phase of) the fort was destroyed by fire. The stones on the rampart originated from the filling of wooden constructions, the remains of which were uncovered beneath the uppermost stone layer. Four post holes wedged with stones were discovered beneath this stone cover, and two of these were located on the outer, and two on the inner edge of the rampart (Figs 1.4 and 1.14). The distance between the outermost post holes was 1.25 m and between the innermost ones 1.85 m; the distance between the innermost and outermost post holes reached 2–2.2 m (thus indicating the width of the rampart). The posts had been 17–30 cm thick. Between the innermost and outermost post holes, remains of wooden cross-walls were discovered; one post on the outer edge was relatively well preserved.

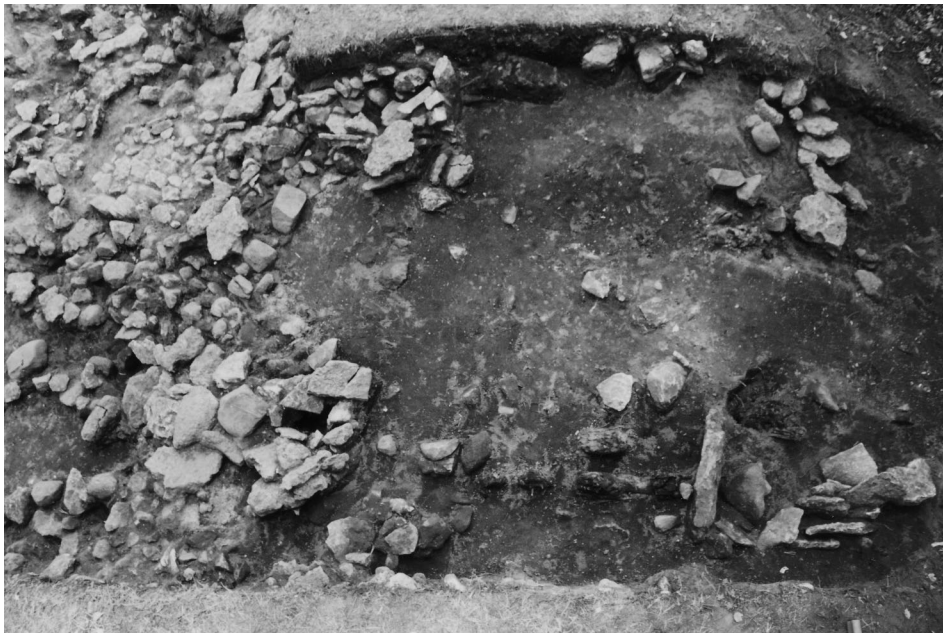
Fig. 1.4. Post holes and remains of timber construction in the area of rampart, fort V or IV. Photo by Valter Lang.

Thus, according to the excavation results, the rampart was built such that both the inner and outer wooden walls were connected with cross-walls made of timbers; the rectangular box-like structures (measured by 2–2.2 × 1.25–1.85 m) that were formed as a result of this were filled in with sand and stones. Beneath the wooden structures there was an earthen bank (formed from both the remains of earlier fortifications and earth taken from aside and added in order to make the base higher and the hill edge steeper). Some form of wooden palisade was probably also located at the top of the rampart. The rampart of fort IV was erected directly on top of the ruins of an earlier rampart (that of fort III), without raising or

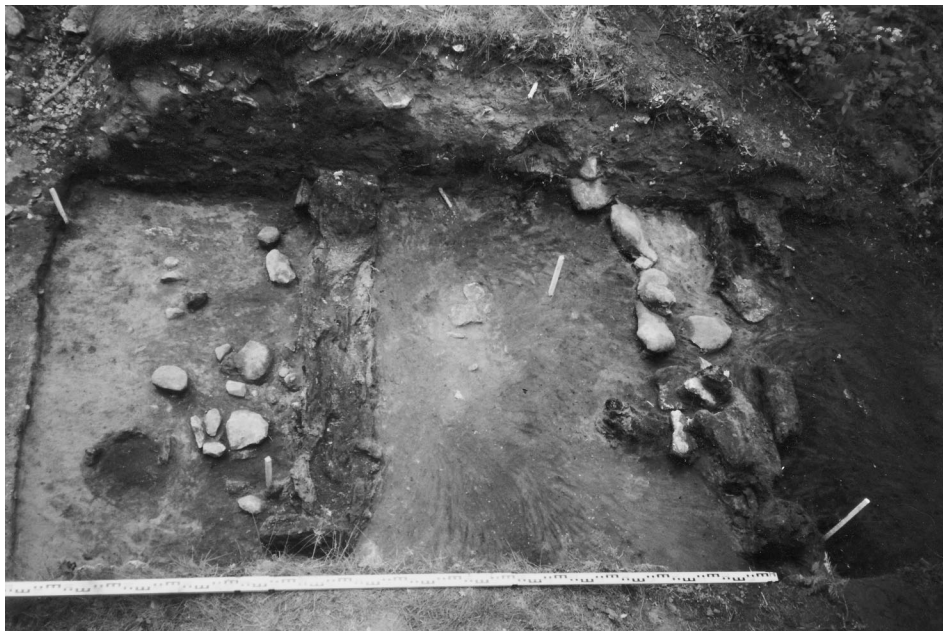
Fig. 1.6. Structures in the rampart (fort II); the inner edge of the rampart is marked with a thick burnt timber. Photo by Valter Lang.

The bank of the rampart was raised ca. 25 cm from the level of the ruins of earlier fort I; at the same time, this bank was widened (the width reached 3 m). Wooden structures, most likely cells as in later times, were erected on this earthen foundation. The width of wooden structures on the rampart was 1.7–2 m. The inner edge of the rampart was marked with a thick burnt timber running lengthwise to the rampart (Fig. 1.6); on the outer edge there were some remains of posts (one in an upright position) and a few stones were preserved. In addition, there were remains of several burnt timbers in the interior part of the rampart, which were radiocarbon dated to the (late 7th) 8th–9th centuries (Tln-2692 and Ta-2809; Fig. 1.5).

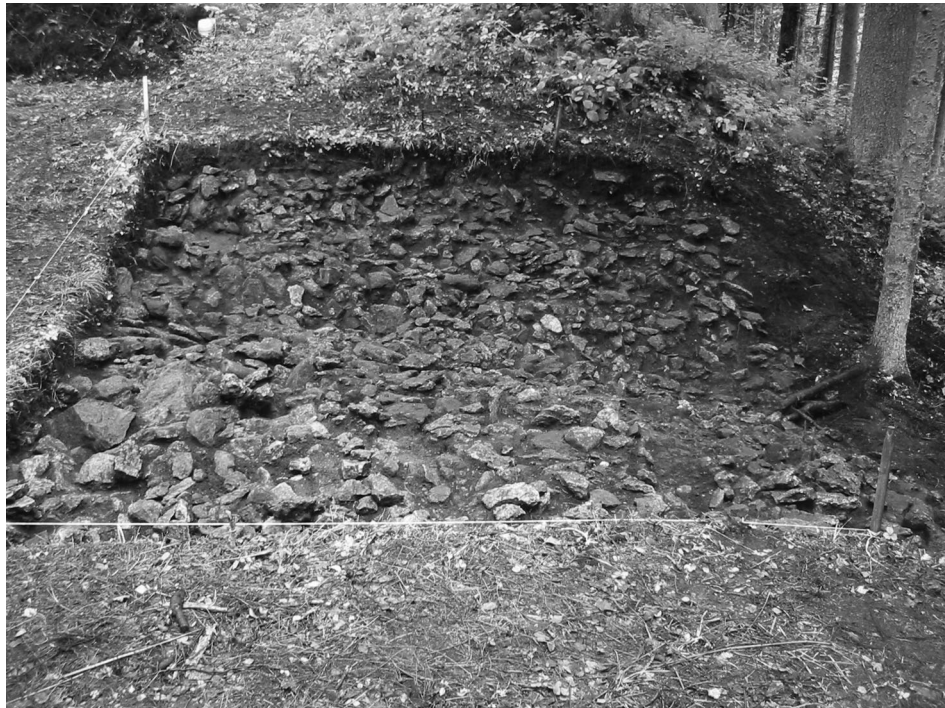
Fig. 1.7. Excavation area II after removal of turf cover, taken from the north-east. Photo by Valter Lang.

After the uncovering of excavation area II, an irregular stone cover consisting mostly of small limestone slabs with traces of burning became visible (Fig. 1.7). No constructions could be observed; nevertheless, the character of this stone cover differed from one part of the excavation area to another. Thus the stone cover was quite thin and incomplete in the north-eastern part of the area (the stones were also smaller there); it is likely that these stones were remains of the part of the rampart that was dropped by the besiegers. After the removal of stones, smaller and larger spots of burnt sand containing pieces of charcoal

In the central part of excavation area II there was a depression, ca 1 m wide, running almost crosswise through the line of the (missing) rampart (Fig. 1.7). This depression was already visible before the excavations and was recognizable as an area with much denser and thicker stone cover when investigating the two uppermost stone layers. It was after the removal of these layers of stones and deeper excavation that the uppermost stones of the walls of a gateway came to light. It became evident that we were dealing with a very narrow and deep-reaching gateway that passed crosswise through the rampart (the outer mouth slightly inclined towards the north) to the slope of the hill (Figs 1.8 and 1.9). The walls of the gateway were piled up of limestone slabs; up to 15 layers of stones (1.2–1.3 m in height) were preserved at some places. The width of the gateway, as measured from the lowermost stones of the walls, varied between 65 and 70 cm; however, the upper parts of the walls had slightly sunk inwards. The bottom of the gateway lay at least 1.6–1.8 m below the original ground surface. Thus it became evident that this gateway had been built not *through* the rampart but *beneath* it.

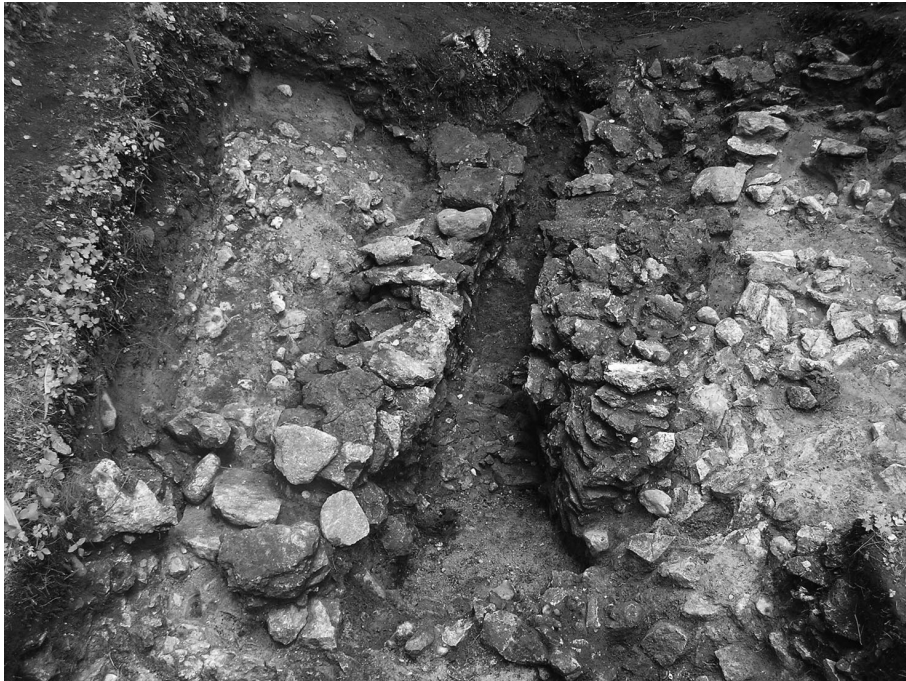
Fig. 1.8. The hidden gateway, pictured from the south-east. Photo by Valter Lang.

However, it became obvious during the excavations that the gateway had quite a complicated structure and consisted of two or even three building stages. In the first stage(s), preceding the gateway with stone walls, there was a wooden gateway. Remains of burnt timbers lying lengthwise to the gate were discovered at the bottom of the trench dug for the gateway (Fig. 1.10), and both under and behind the stone walls of the later stage. The timbers on the bottom of the gateway were covered with a layer of burnt sand and smaller stones, which most likely originated from the collapsed ceiling of the later stage of the gate. The

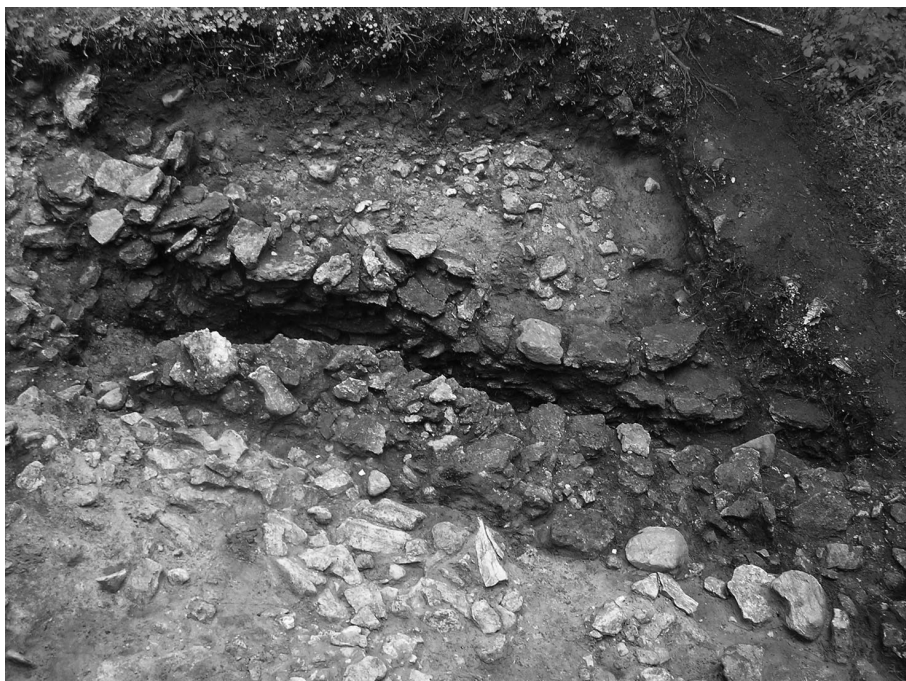
Fig. 1.9. The hidden gateway, pictured from the north-east. Photo by Valter Lang.

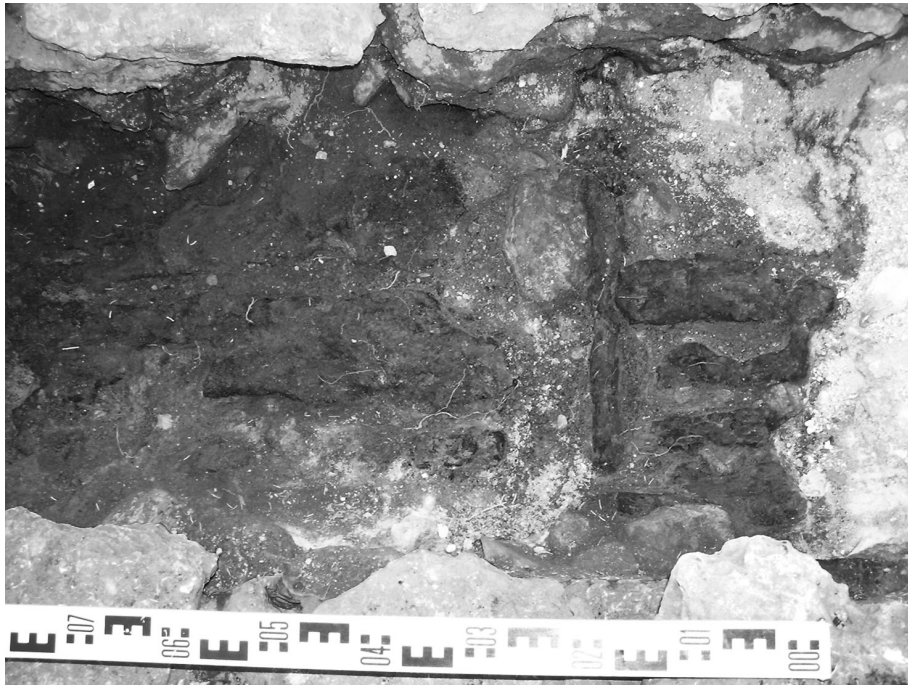
Fig. 1.10. Remains of burnt timbers at the bottom of the trench dug for the gateway. Photo by Valter Lang.

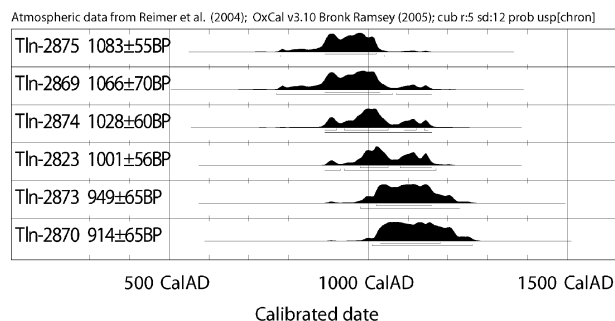
Fig. 1.11. Radiocarbon dates from area II at the hill fort of Keava.

dating of the wooden gateway is, however, complicated. No artefactual finds can be connected with it, and the radiocarbon dates disperse over three centuries if calibrated. Two samples, which were taken beneath the lowermost stones of the walls of the gate (of the last stage), were dated to the 11th–12th centuries (TIn-2870 and 2873; Fig. 1.11). The sample from between the wall-stones yielded a date from the 10th – early 11th centuries (TIn-2869), and approximately the same results were also obtained from the rest of the samples taken from the timbers on the bottom of the gateway (TIn-2875 and 2823). Charcoal found between the

wall-stones may originate from the remains of burnt timbers found behind the stone walls (as mentioned above). These dates coincide with forts III and IV as established in excavation area I. Therefore it appears that it is not at all impossible that the first wooden gateway was already made by the builders of fort III, i.e. in the 10th–11th centuries, and was rebuilt in stage IV. As not all remains of burnt wood were removed during this rebuilding (and not before the building of the later stone gate either), they were mixed and this mixed situation was not visible during the excavations.

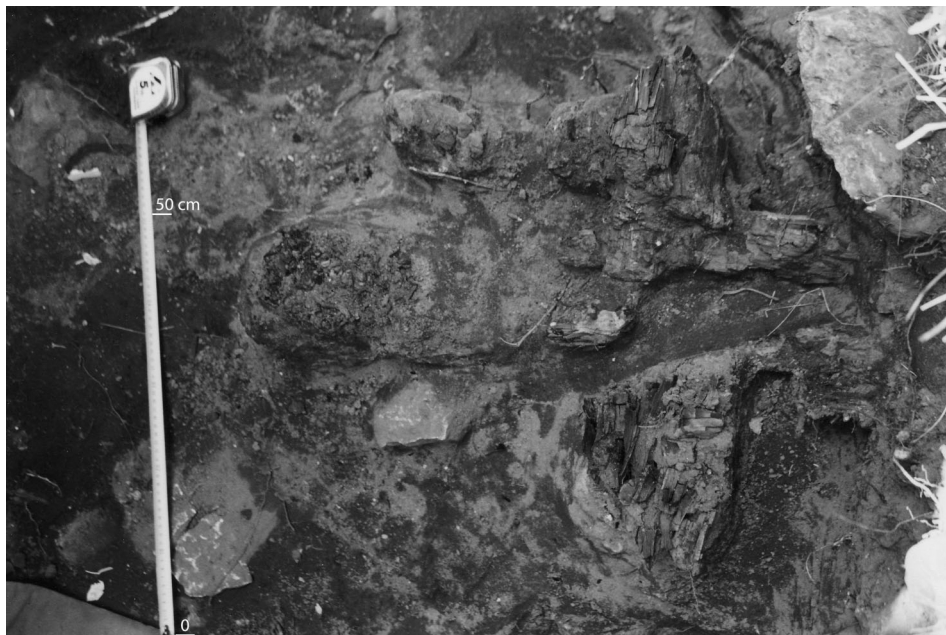
Fig. 1.13. Corner of a wooden construction. Photo by Valter Lang.

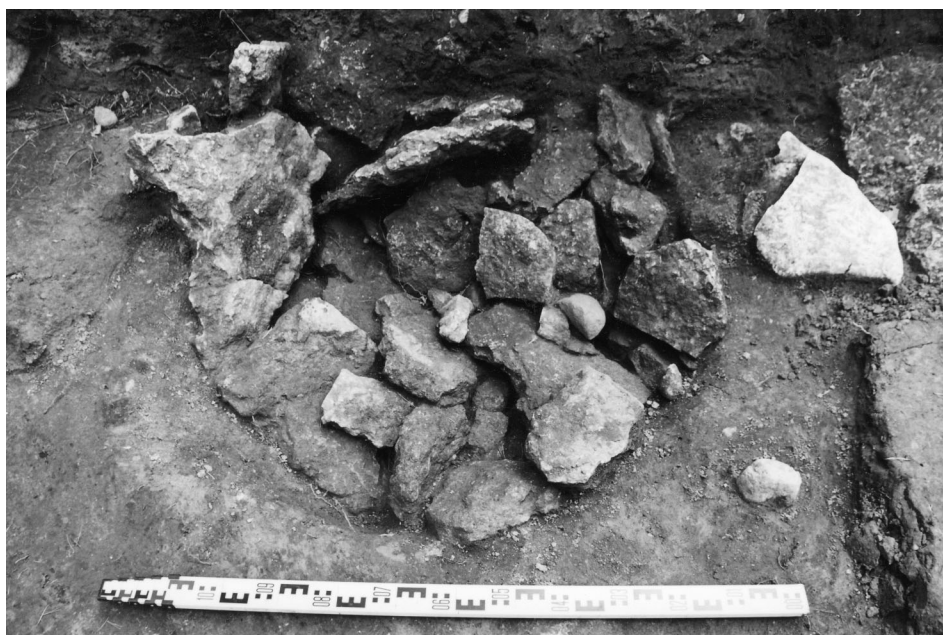
Fig. 1.15. A round-shaped structure. Photo by Valter Lang.

In the south-south-eastern part of the excavation area, we discovered a round-shaped structure (Figs 1.14: VI and 1.15). In the upper part the structure was 125 cm in diameter. It was deepened into the natural ground (up to 85 cm) and surrounded (paved) with large stones (some of them measured up to 50–60 cm). At the bottom, the pit was 75–95 cm in diameter. The whole pit was filled in with smaller stones, while the excavations also yielded potsherds, many pieces of clay daub and a few animal bones. Some potsherds originated from the pot whose pieces were found in the horizon of the last fort. Pieces of charcoal found at the bottom of the pit were radiocarbon dated to 968 ± 50 BP (1010–1160 or 980–1210). This was most likely a household or cellar pit of the last fortification phase; it is not, however, certain whether it was located in the house or outside it.
