CONDITON OF STRUCTURES AND PROPERTIES OF CONCRETE OF AN EXISTING OIL SHALE CHEMICAL PLANT

A case study for investigating the condition of concrete structures and properties of concrete of an existing oil-shale chemical plant is presented. The condition of concrete structures in the plant (constructed in 1951) was assessed visually on a six-point scale. It was found on visual inspection that concrete structures with cracked or spalled concrete cover need extensive repairs. Compressive strength of cores, carbonation depth, cover, water absorption as well as sulphate, chloride and nitrate content in concrete were determined. According to the results suggestions were proposed to repair deteriorated concrete structures in the plant.

General description of the generator building

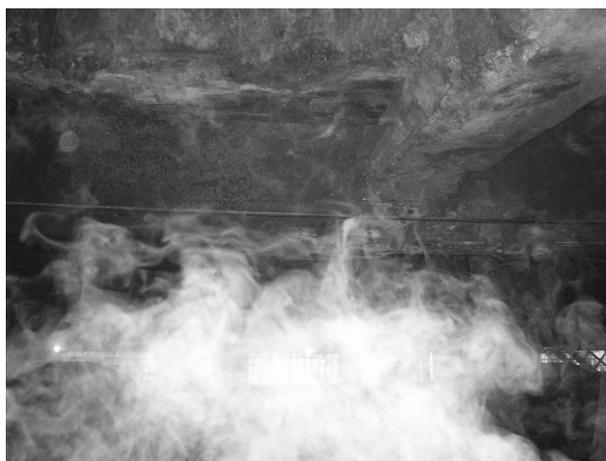
generator. In the generator shale oil is separated by the process of retorting. The generators are continuously filled and emptied. The vertical position of the generators allows them to empty by gravity pull. The conveyor under the generator leads semicoke out of the building. The structures carrying generator are located on the 1st and 2nd floors. As semicoke exits the generator immediately after burning, it is quenched with water which produces a lot of gases (Fig. 1).

Fig. 1. Concrete structures exposed to the gases generated in water quenching of semicoke.

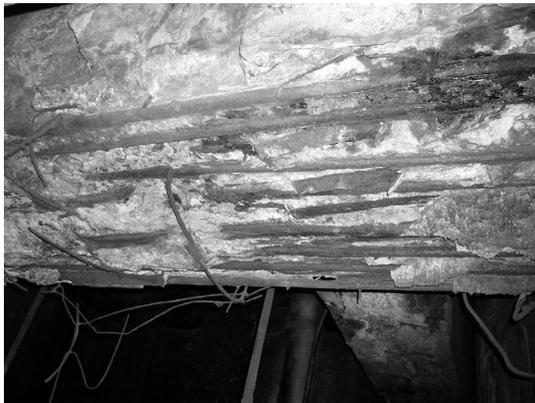
From the structures to which grade 0 was assigned the beams carrying generator on the 2nd floor were in the worst condition. Numerous visually discernible structural deteriorations occurred on those girders and joists. For example, the concrete cover of tensile (but sometimes also neutral or compressive) reinforcing bars has spalled (Fig. 2–3), many stirrups are loose or broken (Fig. 2–3), concrete is delaminated (Fig. 3) or containing incompatible aggregates such as brick pieces etc. (Fig. 2). Due to uniform corrosion the cross-section of longitudinal rebars was not reduced considerably.

Fig. 2. Bottom view of a girder fragment carrying generator on the 2nd floor.

In general, concrete structures with cracked or spalled cover (grade 1 and 0) need extensive repairs from the owner of the building. Cracked or spalled concrete cover does not serve its function of providing fire and corrosion protection as well as bond to the reinforcement. Loose stirrups have to be reattached or replaced during repairs to restore the initial shear capacity of beams on the 2nd floor.

At least the beams carrying generator on the 2nd floor should be treated with steam to reduce the concentration of sulphates and chlorides in concrete. The mortar applied during repairs has to protect the steel by both physical means (i.e. preventing the ingress of deleterious substances) and by chemical means (providing repassivation).

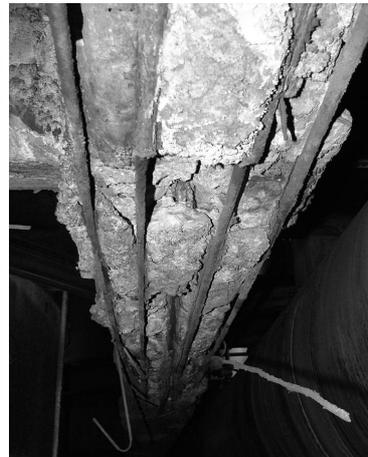
Fig. 3. Bottom view of a joist fragment carrying generator on the 2nd floor.
