Villu Kadakas

## CONFUSION WITH THE “CHAPEL” WALLS IN THE SOUTHERN WING OF PADISE MONASTERY

The ruin of the medieval Cistercian Padise monastery, some 50 km SW of Tallinn has an outstanding position among the survived medieval buildings of Estonia. The monastic complex has developed during several building stages which are represented in complicated stratification. Six trial pits dug in rooms 2 and 2a in the southern wing during conservation works in 2003 gave results which contradict the recognized concept about the architectural development of the monastic complex. Rooms 2 and 2a have for decades been recognized as the earliest stage of the monastery: a chapel built in the 13th century by monks of Daugavgrīva (Dünamünde) monastery. Several specialists have had their doubts about this hypothesis after debris was removed from room 2 in the 1990s. It is obvious from the fieldwork of 2003 that the walls of rooms 2 and 2a definitely do not belong to the earliest stage, but have been erected after demolishing some earlier stone buildings. Several circumstances still suggest as if the outer wall of the southern wing and the conventional quadrangle with its four wings were built after

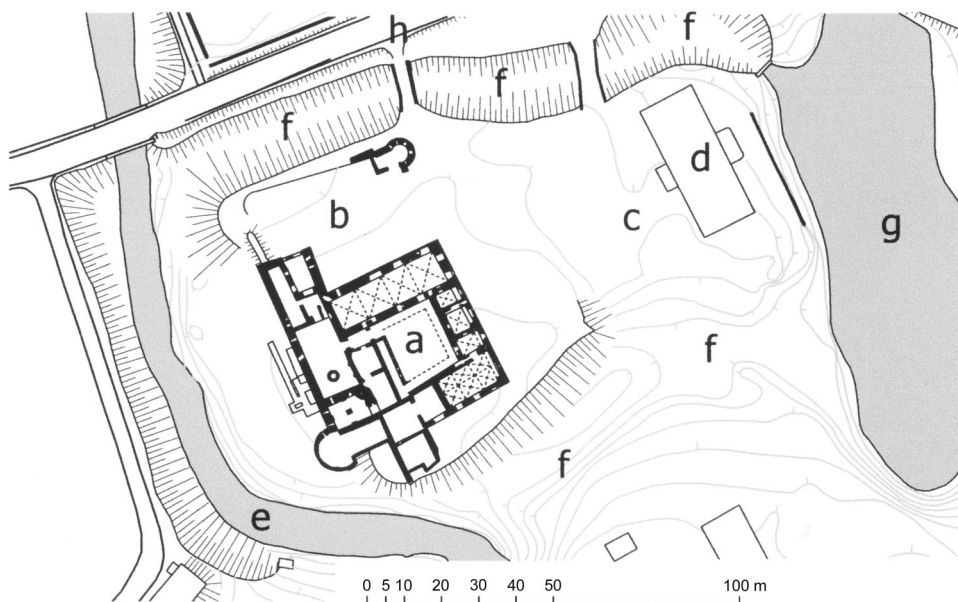
**Fig. 2.** Situation plan of Padise monastery. a ruin of the monastery, b northern bailey, c eastern bailey, d manor house from the 18th century, e River Kloostri, f former moat, g pond, h road.

Looking at the plan of the monastery (Fig. 2) one can notice that the building complex has been positioned very closely to the steep bank of the river on the southwestern side and the southern corner. The same applies to the wall of the northern outer bailey following the moat a few metres away. The moat near the eastern wing of the main body cannot be observed because it has probably been filled if it ever existed in that place. Only the moat near the southern wing has been positioned along the southern wall of room 2a running eastwards at least 7 metres away from the wall of the southern wing. This circumstance puzzled Raam enough so that he dug a trench from the eastern corner of the main body to the bottom of the moat. The results indicated that the moat had never been closer to the southern wing leaving a plateau between the southern wing and the moat. He concluded that the original defences of the monastery might have been located near the bank of the moat away from the later southern wing (Raam 1970, 7), although he did not find any foundation on the edge of the plateau.

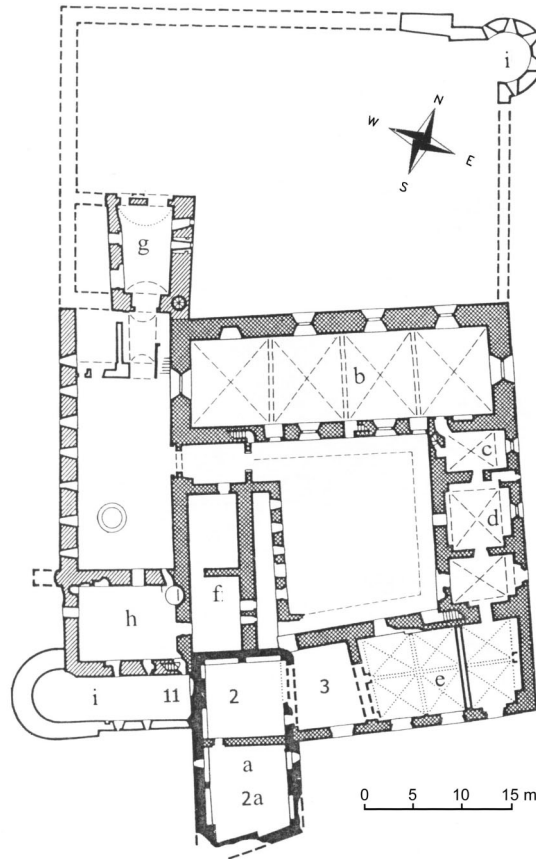
**Fig. 3.** Building stages of Padise monastery by Raam. a chapel, b church, c sacristy, d chapter house, e refectory, f cellar with the well, g tower of the front gate, h defense and dwelling tower, i arquebus towers, 2, 2a, 3, 11 room numbers in the article.

southern wing of the conventional quadrangle (Raam 1997, 43). According to Raam the preserved walls of rooms 2 and 2a should constitute the lower parts of the chapel walls (Fig. 3). Although this room complex is not oriented according to the East–West axis as regular Christian churches and chapels, Raam arrived at this hypothesis by several decorated hewn limestone fragments of portals and a vault system, found in the debris filling these two rooms. These fragments have been dated to the mid-13th century (Raam 1997, 43). The two rooms will be described in detail later as one of the main targets of this paper.

There has been no doubt that up to the level of the arches of the windows of the church the lower part of the outer wall has been erected during one period, the 1st period according to Raam (Raam 1997, 43). On the main floor the inner face of the outer wall in both the eastern and southern wings has been equipped with round arches at least 4 m wide between plain rectangular buttresses (Fig. 3),

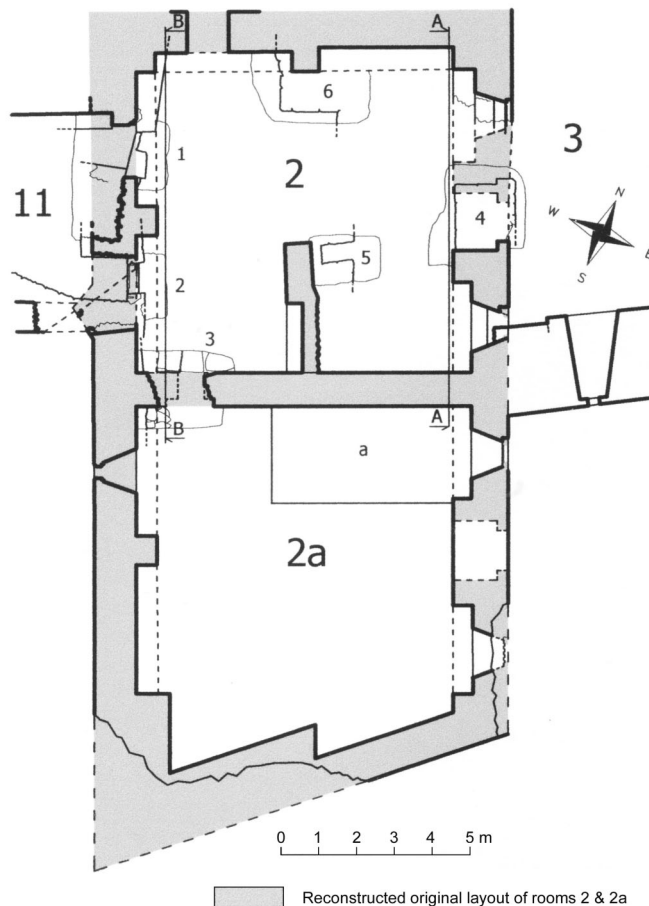
**Fig. 4.** Plan of rooms 2 and 2a. a hypocaust slab, 1–6 numbers of test pits, 2, 2a, 3, 11 room numbers, A–A, B–B sections Fig. 5.

During digging the trial pits of 2003 the walls of room 2 were thoroughly recorded (Kadakas 2005, Figs. 3–6) and studied (Figs. 4–5). The most important modification to the observations of Raam was the discovery that the dividing wall between rooms 2 and 2a is not a secondary addition to the outer walls, but is built together with the latter (Kadakas 2005, 14). It obviously undoes the whole concept of the originally single long room in place of present rooms 2 and 2a. Consequently there have always been two rooms. It is still possible that a single room was on the main floor above but nothing has preserved of it.

Raam detected a fragmented hewn slab with openings for hot air and a vault of a hypocaust stove (Fig. 4) in the northeastern corner of room 2a (Raam 1969, 27). It has not been studied further but the trial pit No. 5 in room 2 revealed remains of some underground stove as well (Kadakas 2005, 17). This stove has been connected with the fragment of a dividing wall which position corresponds to the western edge of the slab in room 2a. It enables to conclude that the two rooms probably shared a common heating system of a hypocaust type around the eastern end of the dividing wall. The details of this heating system still remain vague. There was a doorway in the western part of the dividing wall (in place of test pit 3) preserved in the 1960s but it had totally fallen apart by 2003. A photograph from 1969 (Raam 1969, photo 51) gives a hint that the doorway was a secondary breakthrough, but this aspect was not clearly recorded as no one probably expected it to decay in a few decades. The fact that the jambs of the doorway have utterly broken away like a filling suggests it was indeed a secondary breakthrough.

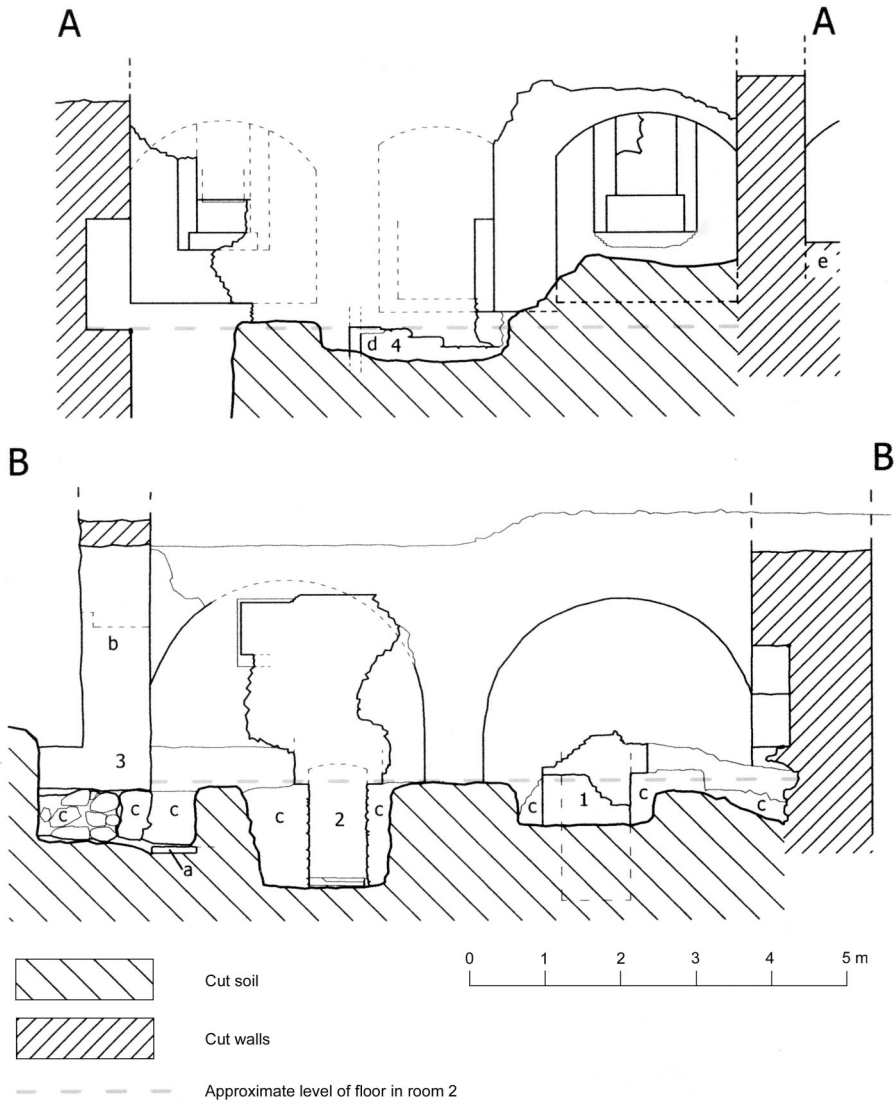
**Fig. 5.** Section A–A and B–B. a floor fragment of limestone slabs, b position of the doorway in the dividing wall, c remains of an earlier wall with two doorways under western wall of room 2, d remains of an earlier portal under eastern wall of room 2, e hypocaust slab, 1–4 numbers of test pits.

Pit 4 was dug under the doorway of room 2 expecting to find a contemporary sill. Instead, the pit presented a fragment of an earlier wall with one jamb of a

hewn portal (Fig. 5: section A–A). Obviously the discovered portal belongs to an earlier building than room 2, the eastern wall of which has been erected almost exactly on top of it. Pit 6 revealed a quite incomprehensible fragment of an earlier wall. The stove found in pit 5 can be connected with the heating system of room 2 itself than with any earlier building.

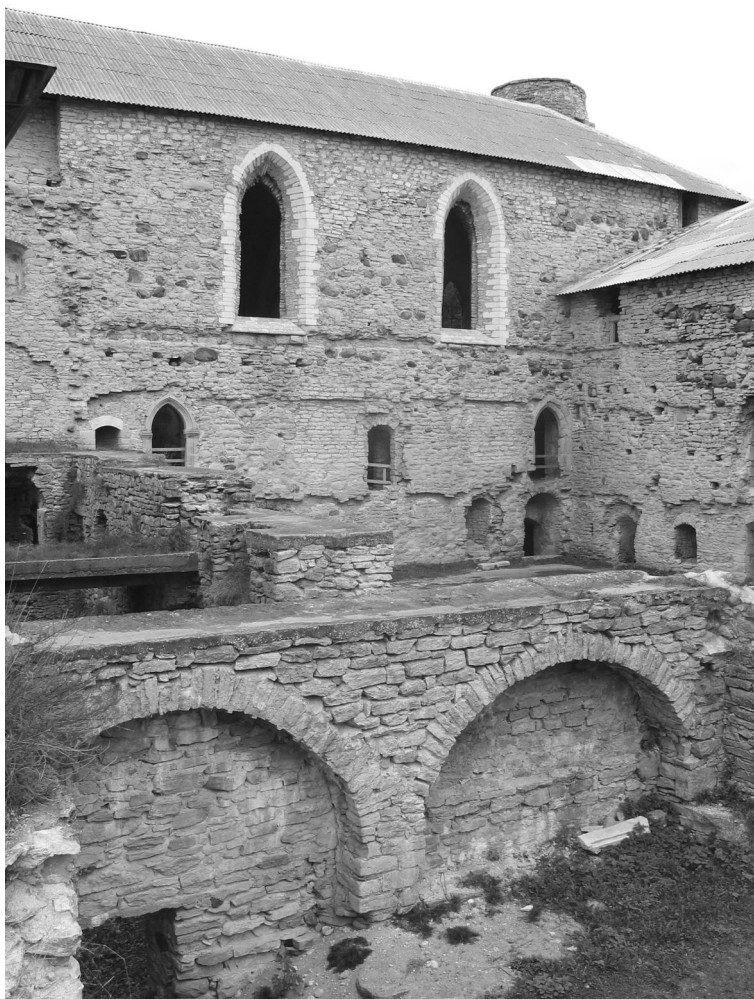
**Fig. 6.** View from room 2 to northeast. Foreground: reconstructed north wall of room 2. Background: south exterior of the church with traces of the two-storey cloister.

It is hard to determine the stratigraphic relations of the northern wall of room 2 with the rooms of the western wing immediately north of it because it has been largely replaced during the restoration works of the 1960s (Fig. 6). It can be supposed by the wall fragment found in pit 6 that it could belong to the original eastern wall of the western wing extending southwards. There are some indications that the western cloister might have originally reached southwards into the area of room 2 as well. If this be true, the wall fragment with a portal found in test pit

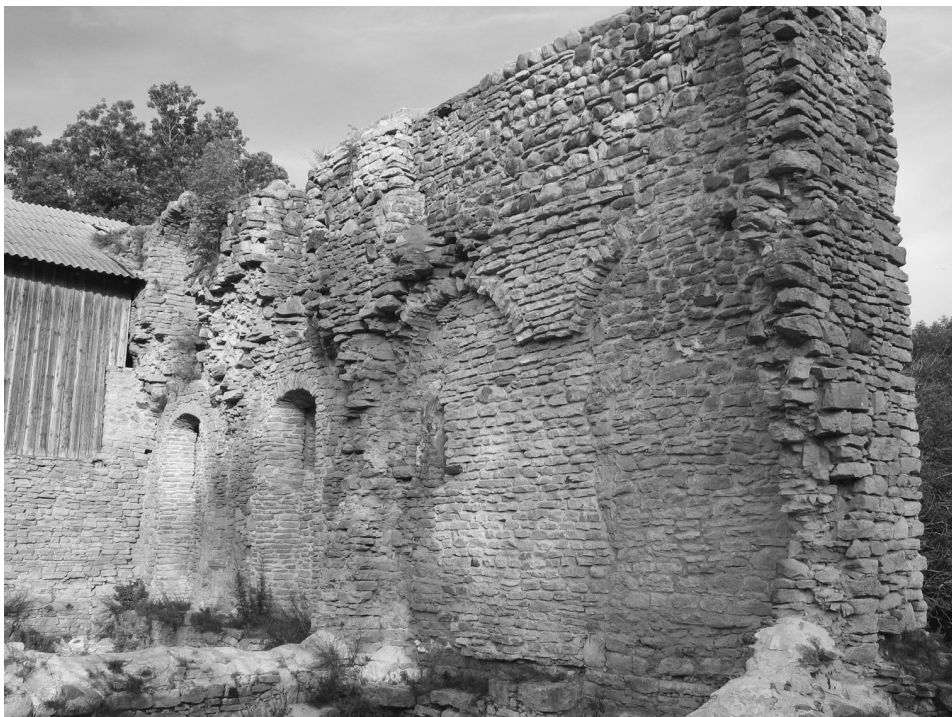
**Fig. 7.** Inside of the outer wall of the main storey of the southern wing.

The outer wall in the area of room 3 (Fig. 7) shows more irregularities on both upper floors. The outer wall on the 2nd floor is considerably thinner than the rest of outer walls of the 2nd floor in the southern and eastern wings and built in a different manner using alternating horizontal rows of limestone and rubble, now partly replaced during conservation. The southwestern corner of room 3 on the first and the second floor has been built as if the southern wing did not continue further towards west. This corner is built of small limestone rubble, i.e. in a clearly different manner than the outer corners of the rectangular main complex. The latter are erected of large hewn limestone quoins. The inner face of room 3 and probably the whole southern wing on the basement storey is mostly covered with secondary coating masonry and therefore cannot be analysed concerning this
