Estonian Journal of  
Earth Sciences  
2026, **75**, 2, 103–121

UAV-SfM photogrammetry, coastal  
geomorphology, Baltic Klint

# Using 3D modelling to identify cliff erosion processes and their controls and to map and predict geohazards: a case study of Pakri Cliff, Estonia

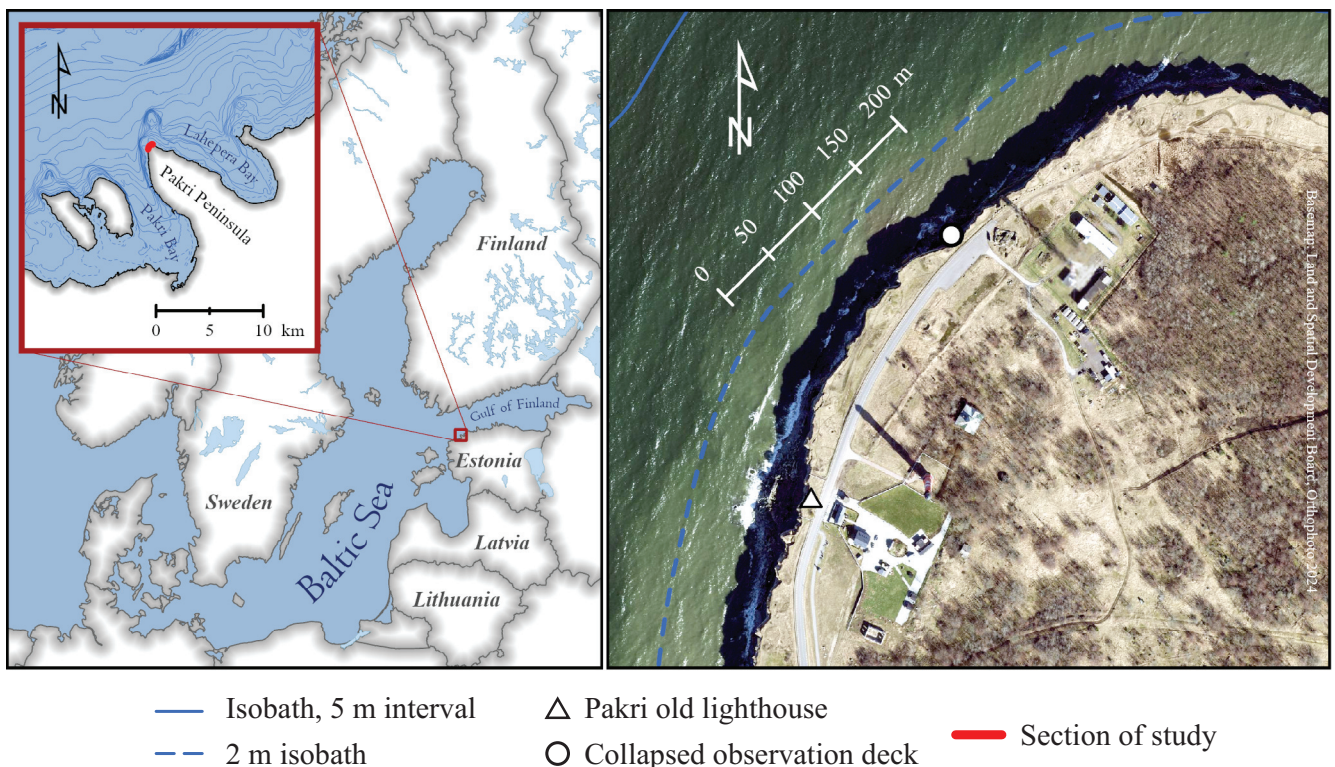
Fig. 1. Geographical location of Pakri Cliff. Basemap orthophoto (2024) and depth isobaths from the Republic of Estonia Land and Spatial Development Board.

The Pakri Peninsula and Pakri Cliff, part of the Baltic Klint, are located in northwestern Estonia between Lahepera and Pakri Bays (Fig. 1). The cornice-shaped escarpment reaches a height of up to 25 m above sea level, gradually decreasing in elevation towards the southeast. The area's land uplift rate relative to the geoid is around 3 mm/year (Suursaar and Kall 2018; Vestøl et al. 2019). Over the past decade, however, the accelerating global sea-level rise ( $\sim 3.7$  mm/year; Calvin et al. 2023) has outpaced this uplift rate, resulting in a positive relative sea-level trend at Pakri at present.

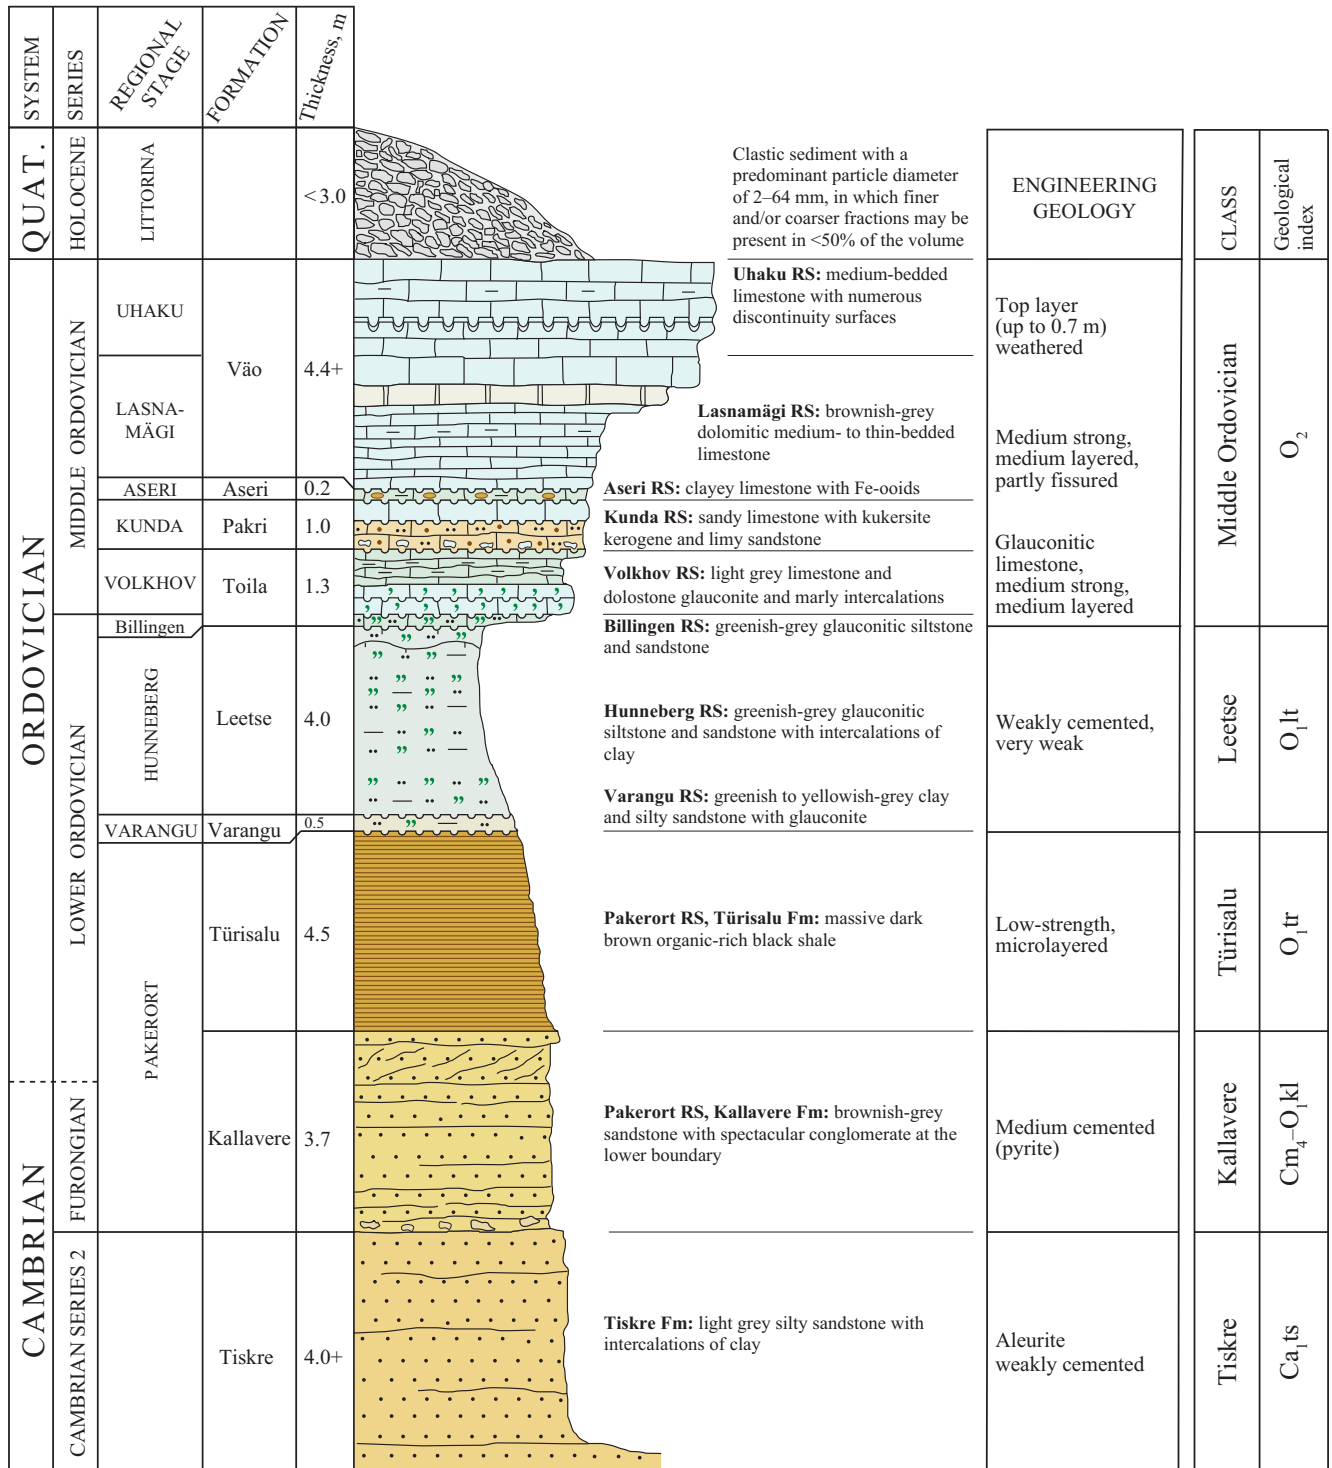
**Fig. 2.** Composite section of the Pakri Peninsula. Modified by Hints et al. (2024) after Mens and Puura (1996). The cross-section has been complemented with a description of the top layer, engineering geological data from the Estonian Geological Archive, and the classification used in the study. Abbreviations: QUAT. – Quaternary, RS – regional stage, Fm – formation.

The cliff profile exposes a composite section of Ordovician and Cambrian sediments with varying lithologies (Fig. 2). The upper third ( $\sim 7$  m) consists of Middle Ordovician car-

bonates, mainly medium- to thin-bedded pack- and wacke-stones. This section is strongly jointed due to tectonic stresses, producing a characteristic zigzag cliff edge. According to Miidel and Raukas (2005), the mean distance of NW–SE joints is 0.5–3 m (seldom up to 10 m), while that of joints with a NE–SW orientation is 2–3.5 m (seldom 25–40 m). Orthogonal joint systems are least frequent, with distances between them ranging from 8 to 40 m. Beneath the carbonates lie Lower Ordovician, Furongian, and Lower Cambrian sand- and siltstones interbedded with clay. Vertically lower formations (Fms), such as Kallavere and Tiskre, are subject to wave

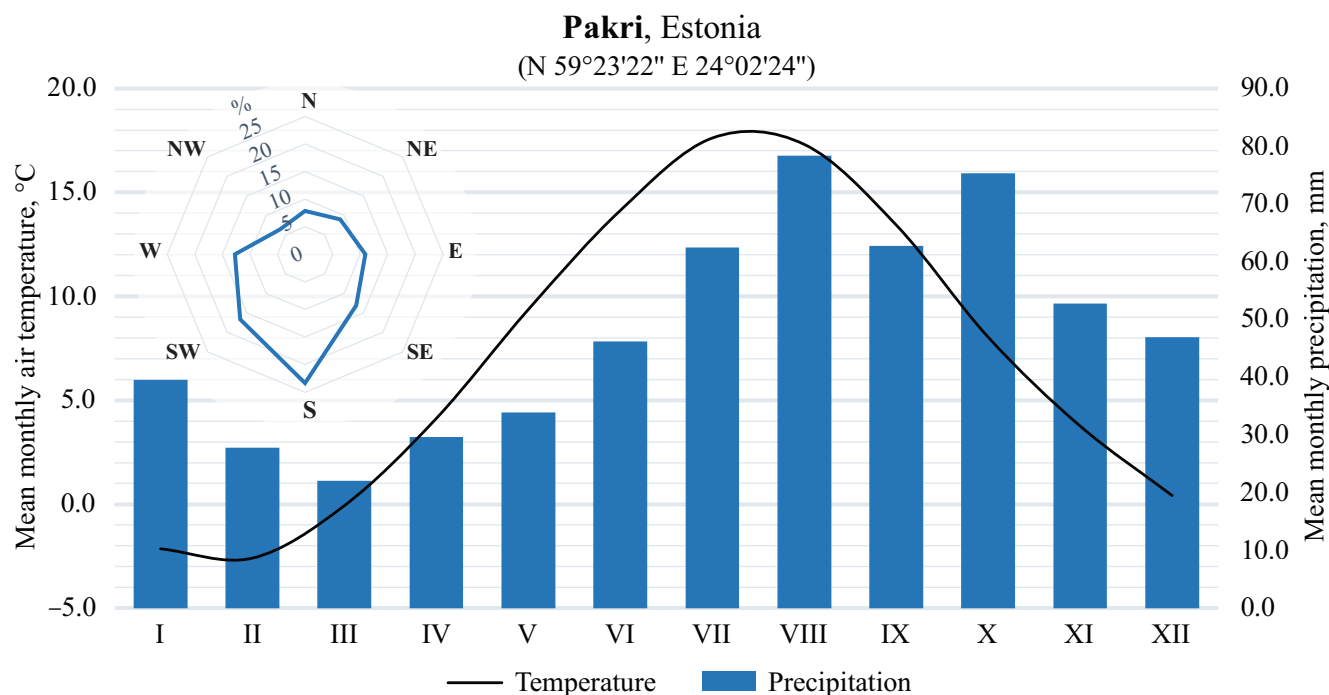
**Fig. 3.** Pakri climate diagram and wind rose based on measurements from the Pakri meteorological station. The figures are derived from hourly data collected over the past 20 years (January 2004 to December 2023). Precipitation measurements from November to March may differ from actual values, as the early data (2004–2009) were recorded using a device that was not operational during the winter season.

The Pakri Peninsula has a transitional climate (Fig. 3). The mean annual temperature is 7.0 °C, ranging from –2.6 °C in February to 17.6 °C in July. Total annual precipitation is approximately 580 mm, with the majority – approximately

60% – falling between July and November. The prevailing winds are typically stronger and originate from the south, southwest, and west. The annual average wind speed is 4.6 m/s, with higher velocities observed during late autumn and early winter and lower velocities from May to August.

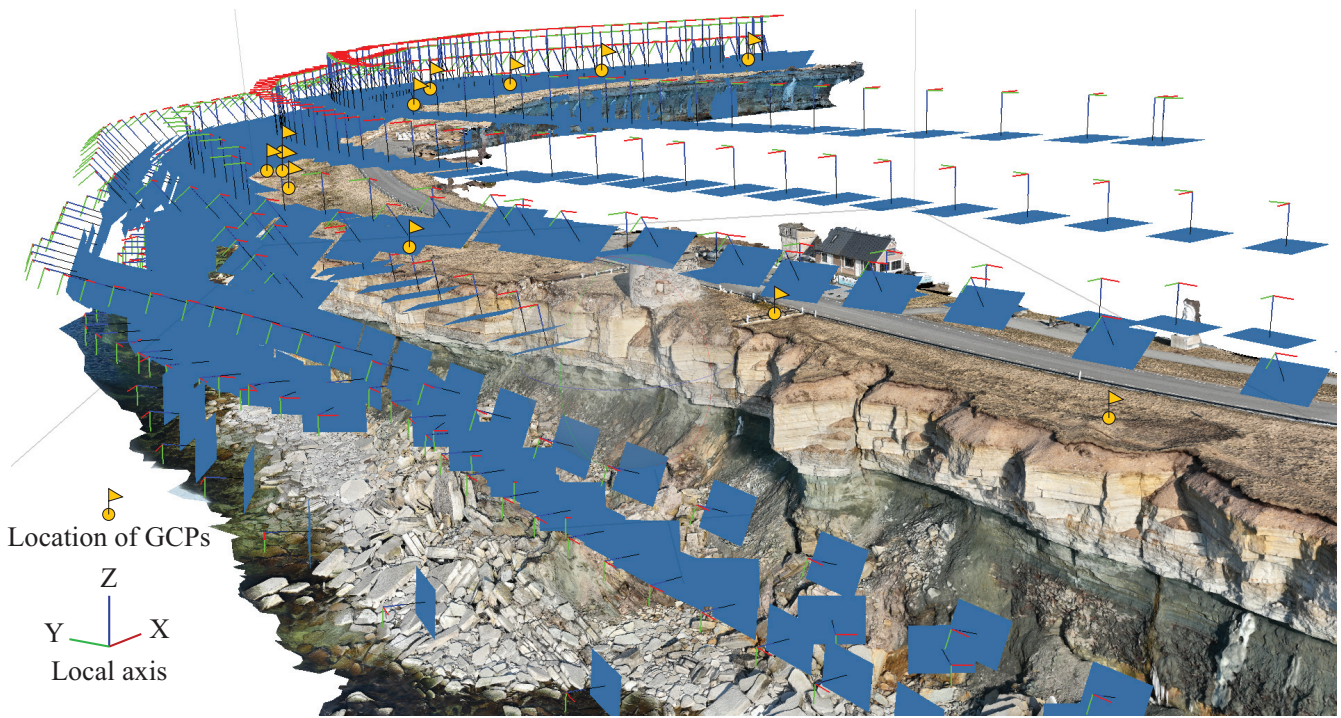
Fig. 4. Image coverage and ground control points (GCPs) in the March 2024 model.

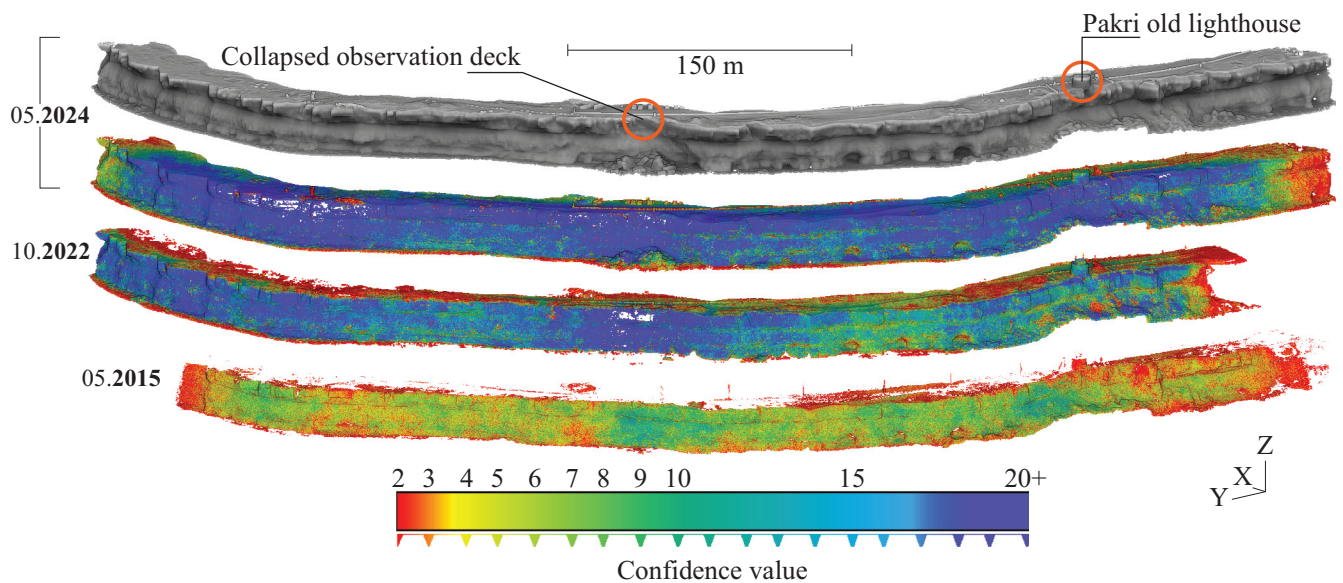
Fig. 5. Distribution of confidence values across point clouds. Values below 2 have been removed to improve accuracy.

Confidence values indicate the number of depth maps used for generating one point in the point cloud (Fig. 5). Depth maps are calculated when two images share over 100 matching points. Combined depth maps for one camera are transformed into a partial point cloud and merged into a dense point cloud. Therefore, lower confidence values are generally located in the model border areas and on rapidly changing or partially hidden surfaces, such as the back wall and bottom of small notches and the hidden bottoms of lower limestone layers.

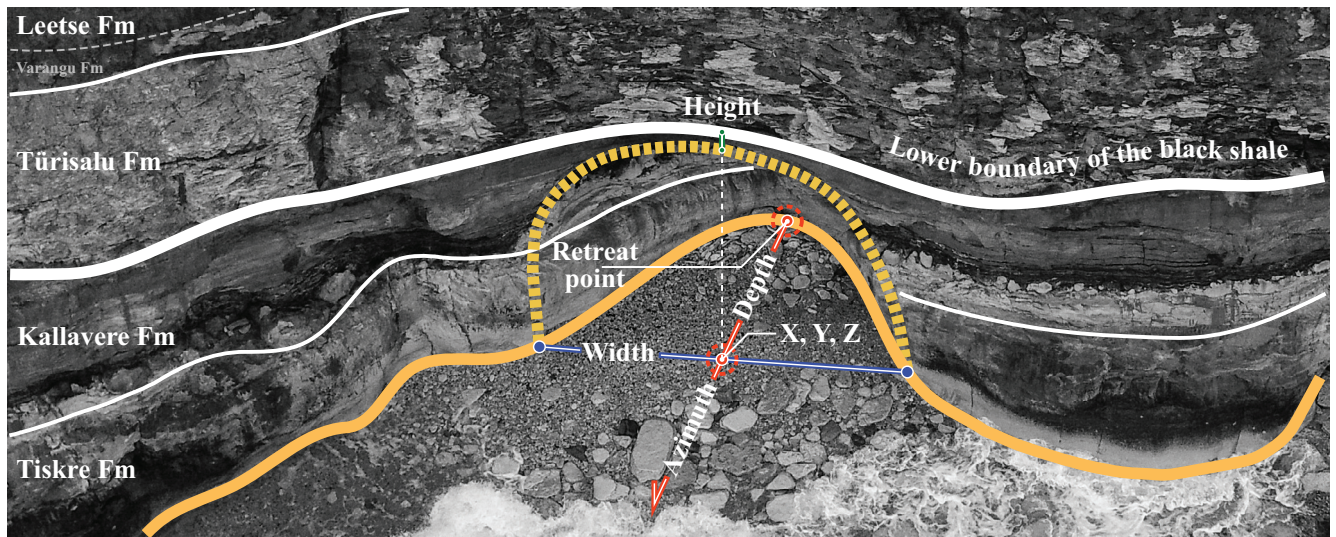
Fig. 6. Visualisation of the measured morphometric parameters of a coastal notch. The X, Y, and Z coordinates represent the midpoint of the notch mouth.

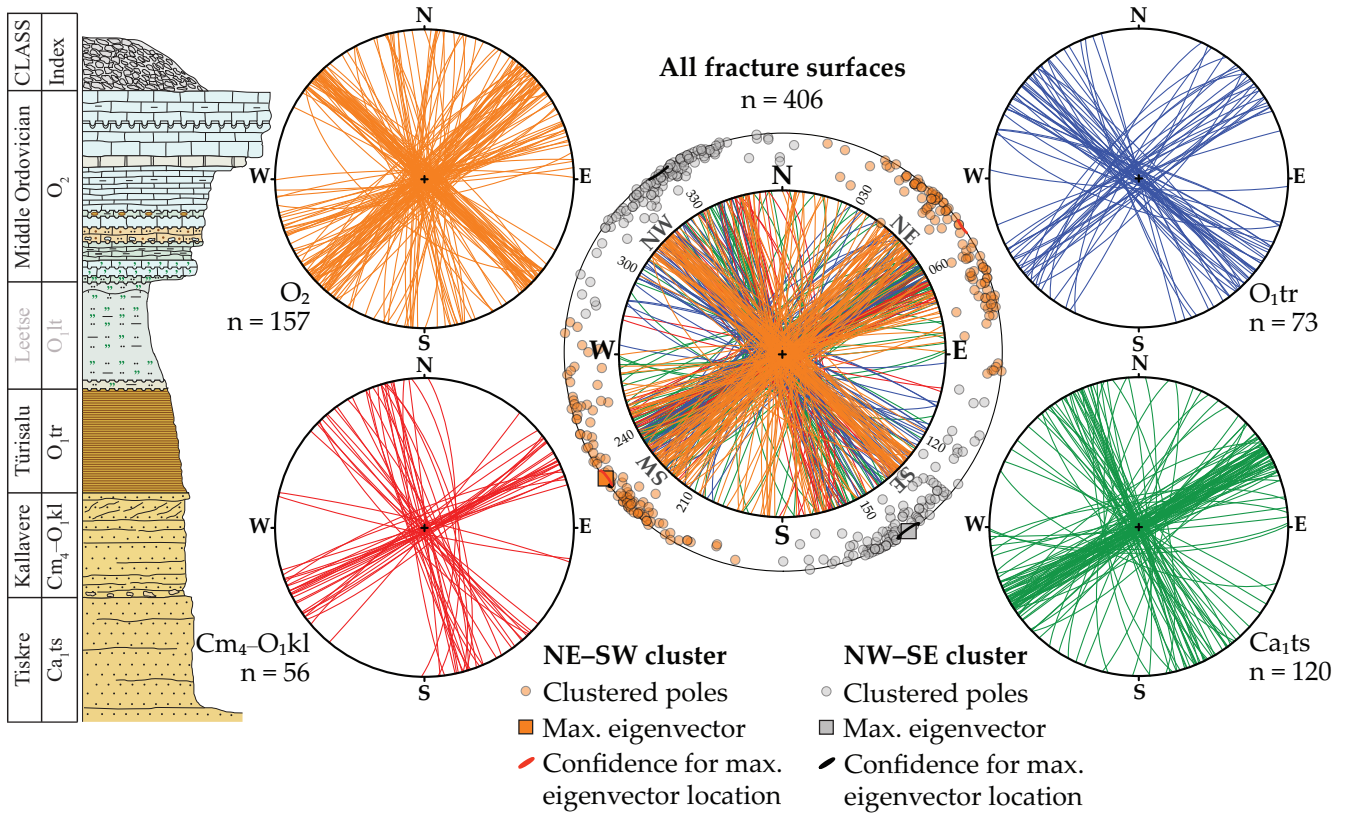
Fig. 7. Stereonets of mapped fracture surfaces, with clustered orientations plotted as poles. Projected on an equal-area lower hemisphere.

Smooth fracture surfaces representing vertical joint systems were observed in all mapped formations except in Leetse Fm, where they remain hidden due to the relatively soft and friable rock (Fig. 7). It is noteworthy that faults were

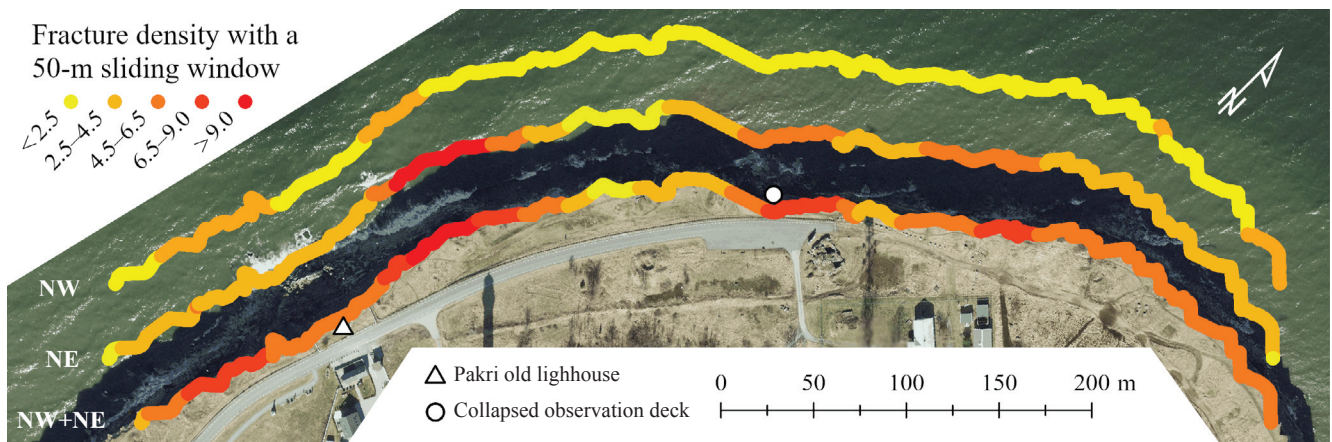
Fig. 8. Fracture density in Middle Ordovician carbonates within a 50-m sliding window, with separate profiles for NW-oriented, NE-oriented, and all joint sets.

Whereas spherical stereonets depict joint orientations and dip, density maps visualise the geographical location and distribution of these features. Joint density was evaluated based on fractures mapped in the limestone blocks due to being outlined and visually observed along the total survey section (Fig. 8). However, it is important to note that only fractures with a clear and recognisable surface were mapped, and the overall fracture network in both directions may be significantly more extensive. Assessing the fracture apertures proved difficult, as they were either not present or could not be detected in the model.

The spatial distribution of the fractures exhibits some variability along the coast. While NW-oriented fractures are relatively evenly distributed across the section, with occasional areas of higher concentration, the NE set exhibits a denser and more clustered pattern.

ential erosion. Notches in more advanced stages of development extend up to the black shale but have not penetrated it. In general, notch depth tends to increase with height, and wider notch mouths are linked to greater incision depth and height. The spatial distribution of notches and proto-notches is concentrated in two clusters, each approximately 200 m in length. The first is located between the old lighthouse and the collapsed observation deck, with predominantly NW-oriented, high and deep features, and the second extends about 100 m further, ending at the eastern boundary of the study area where shallower N- and NE-oriented features dominate. The morphometry and orientation of the retreat point indicate that most of the formations may have been initiated by intersecting fracture systems (Fig. 8).

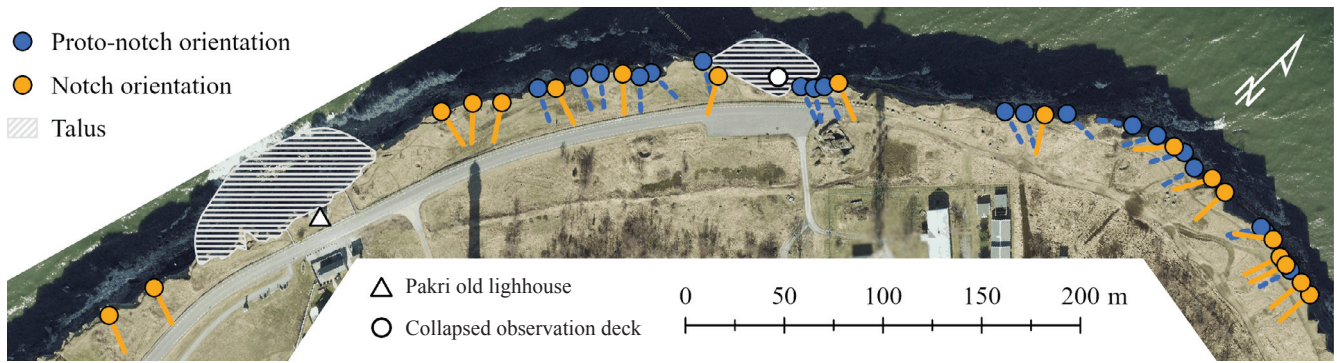
Fig. 9. Distribution and orientation of coastal notches and proto-notches.

Coastal notches, mapped from the May 2024 model, exhibit a wide range of shapes and sizes, varying from small and shallow indentations to pronounced cavities several metres wide and deep. Along an 800-m-long cliff edge, of which approximately 200 m is protected and obscured by fallen talus, a total of 18 notches and 19 horizontal V-shaped indentations, which appear to represent an early stage of notch formation (proto-notches), were mapped (Fig. 9).

Coastal notches have mainly developed within the weakly cemented, aleurite-rich Tiskre Fm, and have been primarily shaped by wave abrasion. They extend slightly into the conglomerate layer at the base of the overlying Kallavere Fm. In a few instances, where the conglomerate is thicker, the notches exhibit step-like incision patterns, indicating differ-

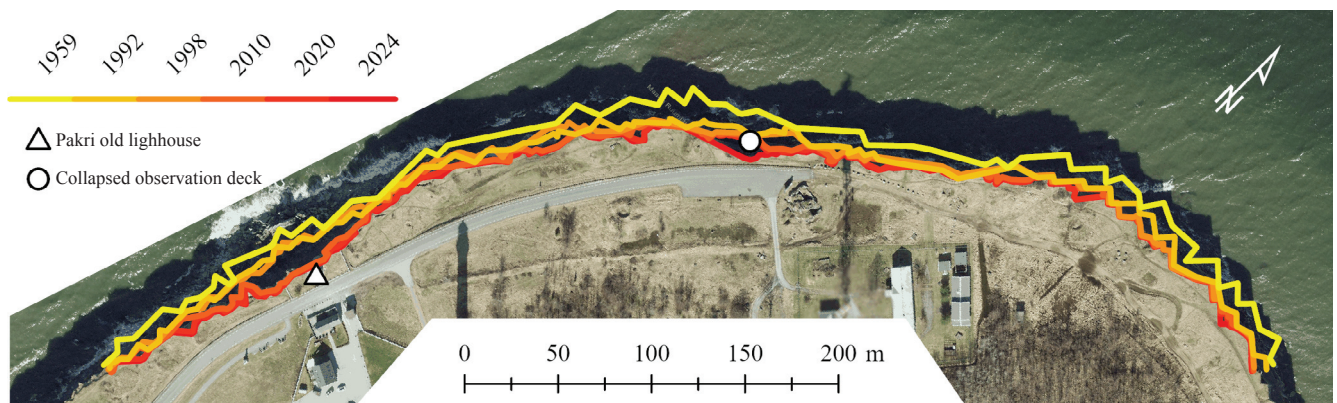
Fig. 10. Cliff edge retreat over 65 years.

Orthophoto analysis covering the period 1959–2024 indicates a cumulative cliff edge retreat of approximately 9670 m<sup>2</sup>, consisting of discrete rockfalls in the upper section. Major collapse events reported in the media during this century include the collapse of the observation deck (~240 m<sup>2</sup>) on 16 January 2024, the detachment of a limestone block (~10 m<sup>2</sup>) near the old lighthouse, damaging part of the footpath, on 22 April 2021, and multiple substantial failures (~1050 m<sup>2</sup>) between 2–4 March 2008, which removed a large section of the cliff and reached the foundation of the historic lighthouse.

mated area of 250 m<sup>2</sup> in the eastern cliff section. A more pronounced retreat occurred between 1998 and 2010, with a total area loss of 2290 m<sup>2</sup>, primarily concentrated near the Pakri old lighthouse, the collapsed observation deck, and the adjoining areas. During the subsequent decade (2010–2020), the cliff exhibited relative stability, with a reduced retreat of 870 m<sup>2</sup>, although localised changes were noted along the zigzag edges in the eastern and western sections. In the current decade (2020–2024), ongoing processes, including the collapse of the observation deck, have resulted in an additional retreat of 650 m<sup>2</sup>.

The cliff edge length, as determined from the 2024 orthophoto, is 810 m. Comparing the first and last orthophotos, spanning 65 years, the linear retreat rate is 18 cm/year. Between 1992 and 2024 (32 years), the rate is 16 cm/year, and between 2010 and 2024 (14 years), it is 13 cm/year. The arithmetic mean of the three results is 16 cm/year, while the weighted mean is 17 cm/year. The most significant erosion has been observed near the Pakri old lighthouse and the collapsed observation deck, where the estimated rate reaches 30 cm/year. In other areas, the rate of erosion is comparatively lower.

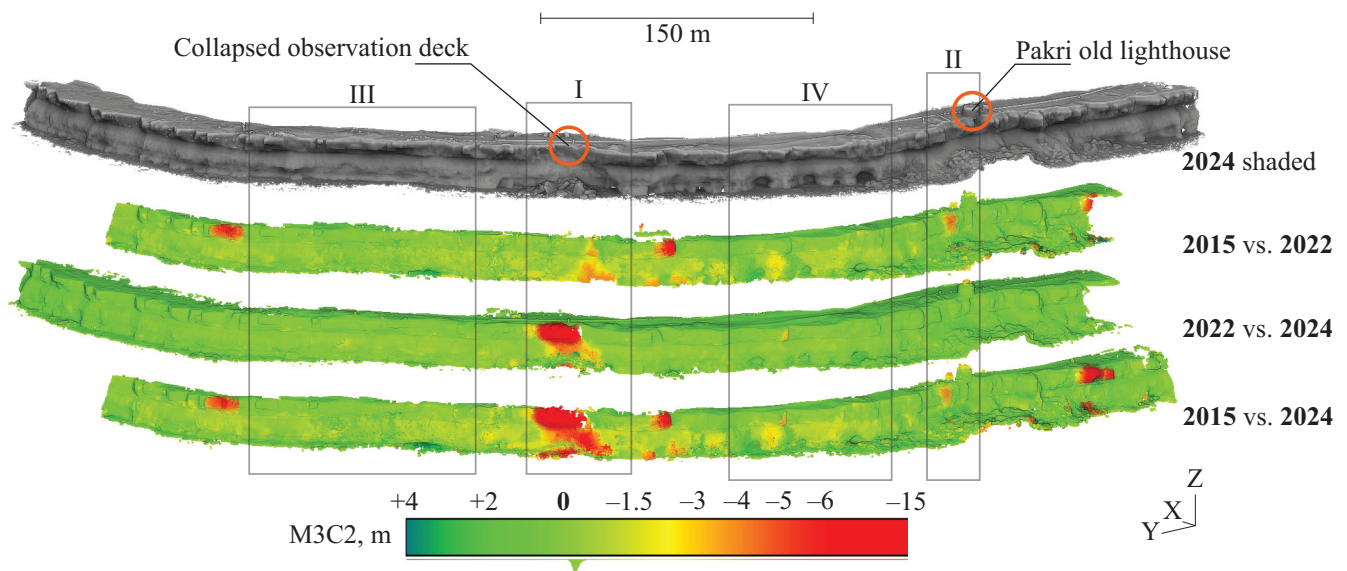
**Fig. 11.** Changes in a section of the cliff face over time. I – location of the collapsed observation deck, II – collapse of the limestone block, III – retreat of glauconitic sandstone, IV – notches. Abbreviation: M3C2 – model-to-model cloud comparison.

During the study, three general erosion-accumulation models were generated using dense point clouds (Fig. 11), representing changes over the periods 2015–2022, 2022–2024, and 2015–2024. The most significant changes in the 2022 model, compared with 2015, were observed approximately 40 m southeast of the collapsed observation deck, 15 m north of

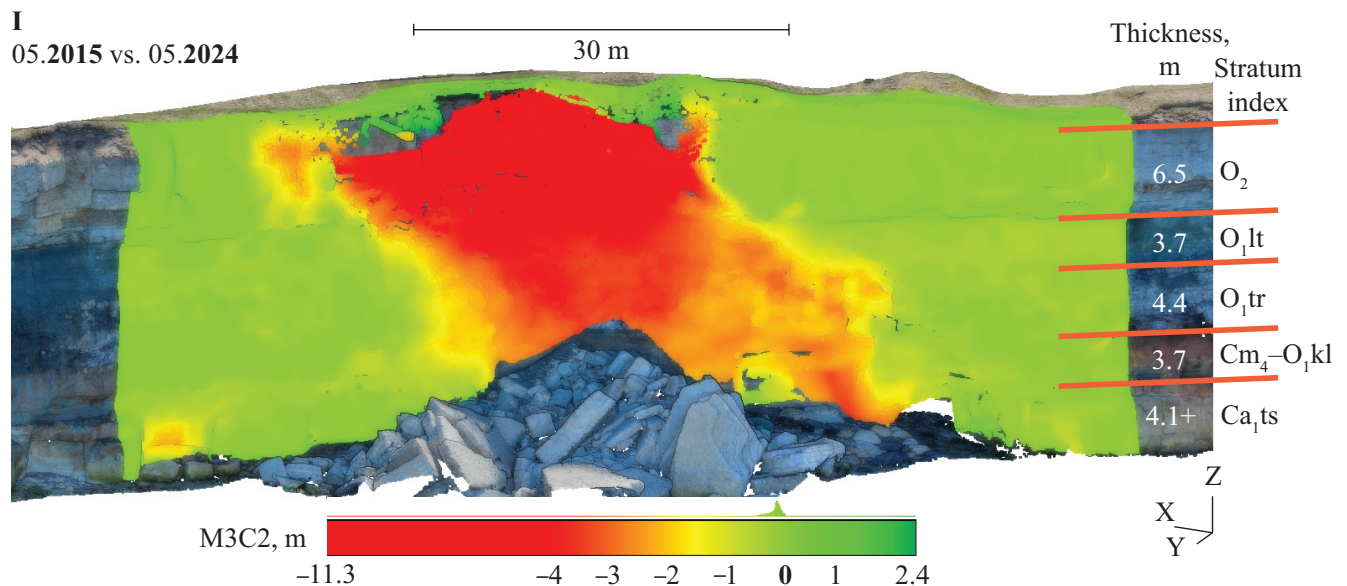
**Fig. 11A.** Section I – changes associated with the collapse of the Pakri observation deck.

the old lighthouse, and in the southern section of the zigzag cliff edge. Furthermore, a significant collapse is partially visible near the model's edge, approximately 70 m from the old lighthouse; however, the 2022 model is shorter than the others, and the full extent of the collapse is not entirely apparent, but it is still visible in the 2015–2024 model. The most significant change in 2024 compared with 2022 occurred at the location of the observation deck that collapsed in January 2024.

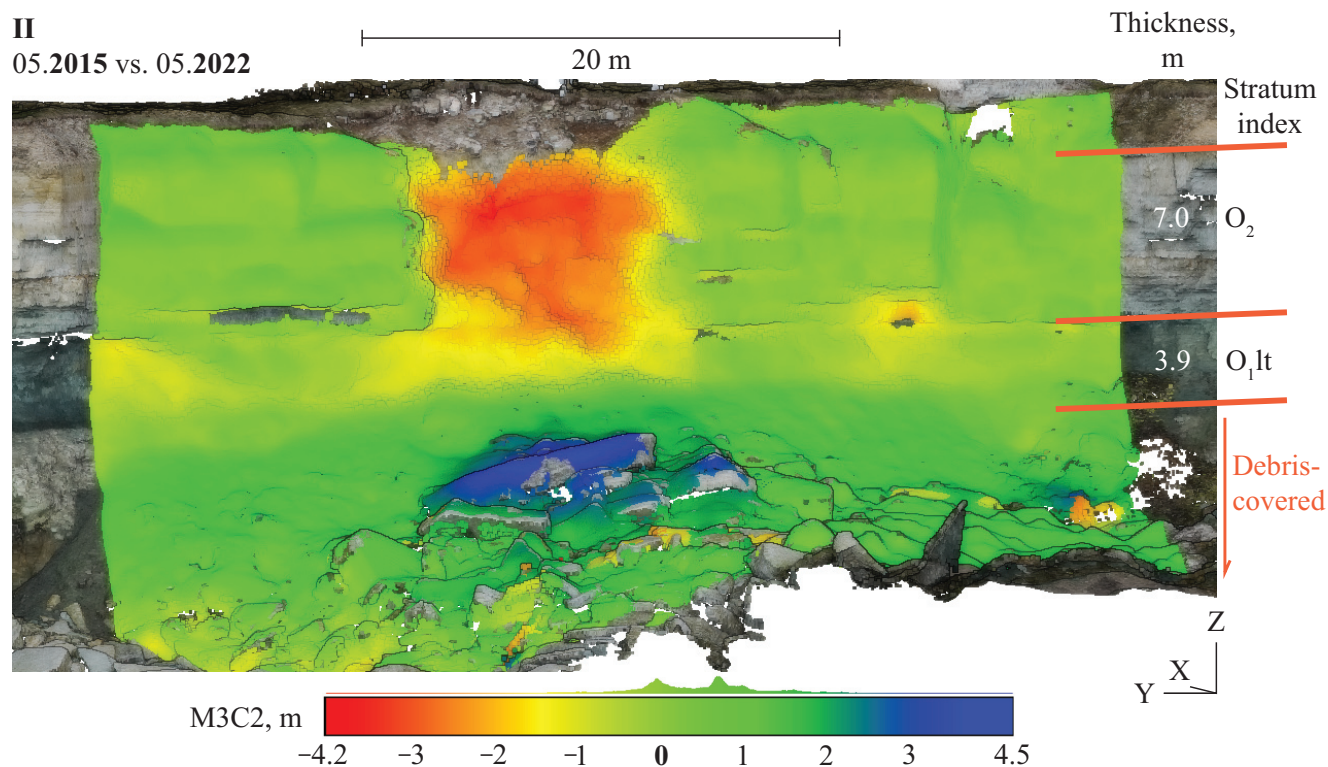
Fig. 11B. Section II – collapse of a limestone block next to the Pakri old lighthouse.

Secondly, on 22 April 2021, a block of limestone nearly 10 m wide collapsed next to the old lighthouse (Fig. 11B). The collapse of the approximately 340 m<sup>3</sup> block caused a cliff edge retreat of nearly 3 m. The height of the talus increased by around 4.5 m.

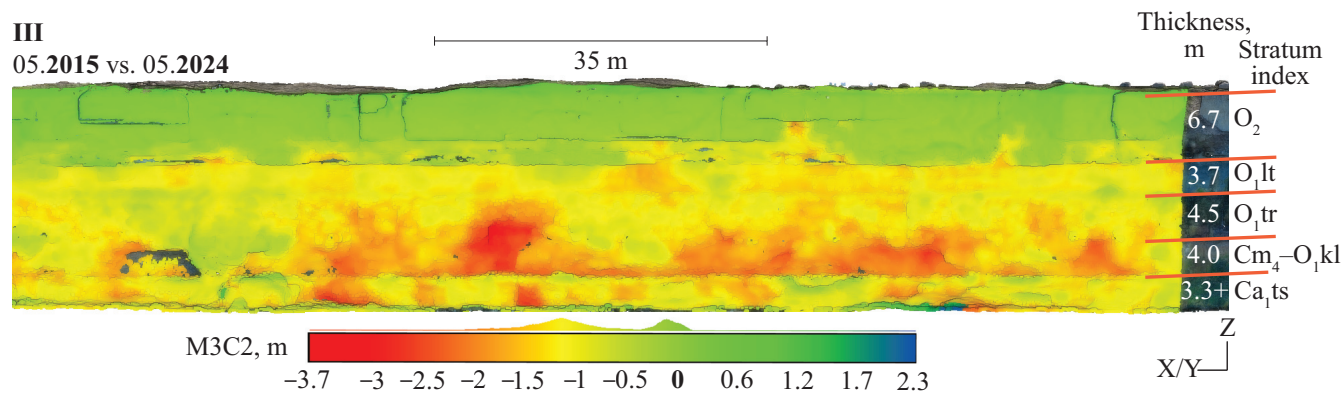
Fig. 11C. Section III – retreat of lower sandstone.

Thirdly, changes in the more friable rocks beneath the Ordovician strata were compared (Fig. 11C). Unlike limestones, which fall in blocks, the regression of sandstone has been relatively continuous and uniform throughout the cliff. There has been less loss in locations where the debris slope has protected the cliff toe from waves. In contrast, fine sandstone sediments are immediately washed away and do not form talus.

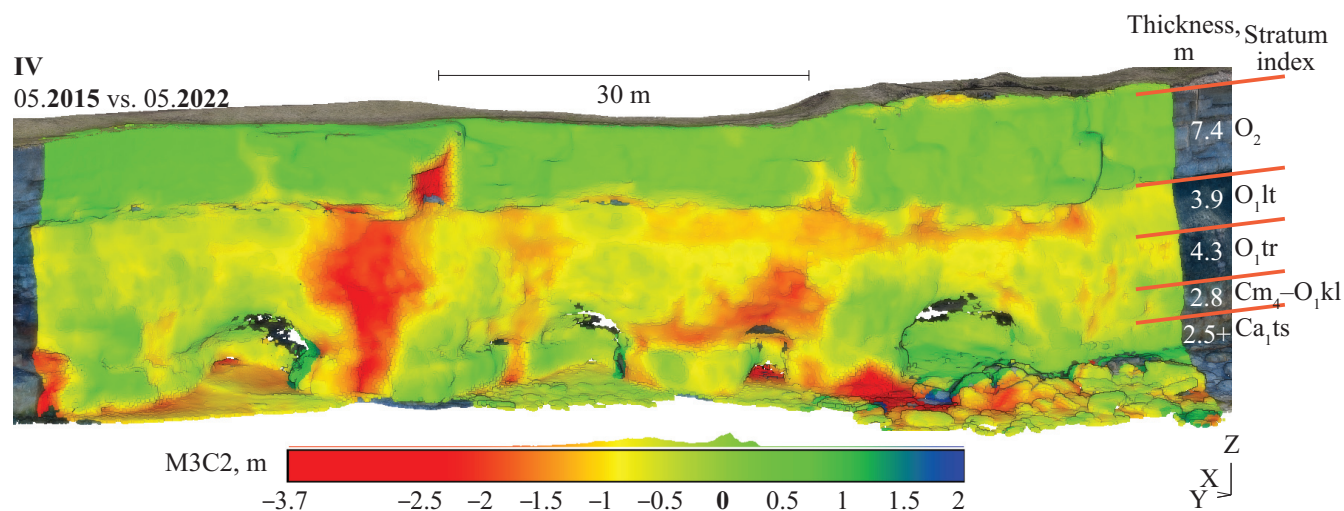
Fig. 11D. Section IV – coastal notches.

Finally, the abrasion notches were examined (Fig. 11D). No major collapses had occurred within the coastal notches. However, approximately one metre or more of material from the bottom of the notches had been washed away and replaced

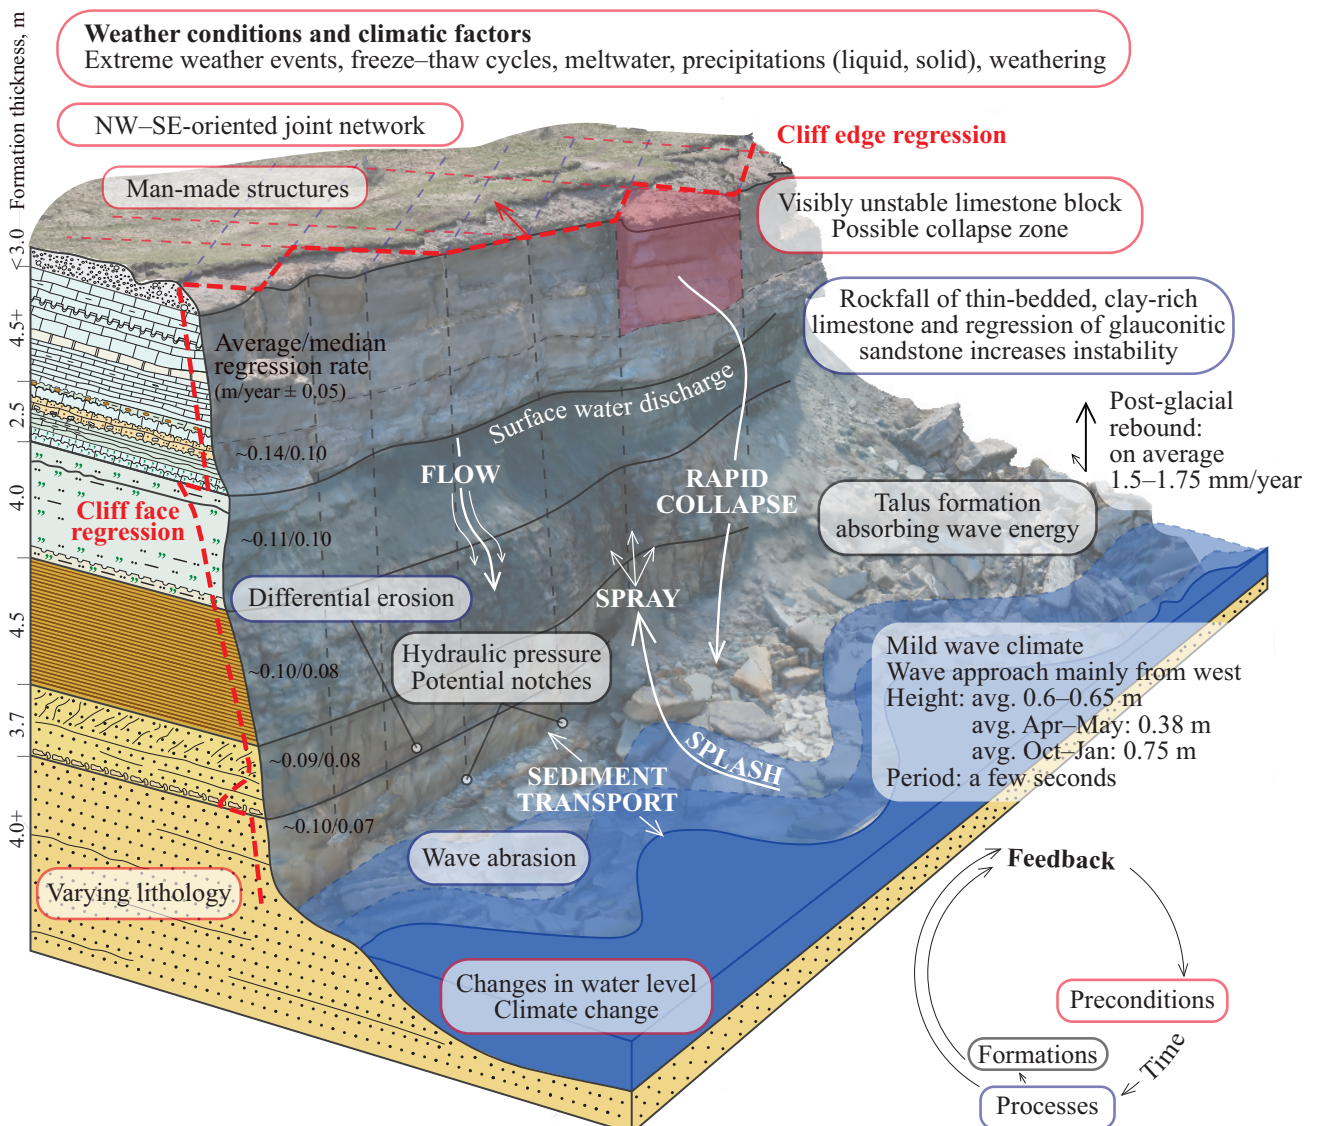
**Fig. 12.** Conceptual model of Pakri Cliff retreat. Average wave climate characteristics are adapted from Soomere and Räämet (2011), and the land uplift rate relative to the geoid is based on the NKG2016LU<sub>lev</sub> model (Suursaar and Kall 2018; Vestøl et al. 2019). A detailed overview of the relevant processes, controls, scales, and feedbacks is presented in Table 3.

The conceptual model synthesises the geomorphological and environmental factors that drive cliff retreat (Fig. 12).

Pakri Cliff is characterised by rapid rockfall in the limestones, gradual regressive weathering in the middle sandstone, and slow wave erosion below. Rockfall is controlled by joint systems and promoted by weather conditions such as freeze–thaw cycles and precipitation, as well as being triggered by mass movement. In areas with denser intersections of joints – such as near the collapsed observation deck and the old lighthouse – cliff retreat has been somewhat faster, likely due to additional stress from near-edge structures. In the Leetse Fm, regression is constant, slowing down during the colder season, when liquid precipitation is less abundant. Rainwater infiltrating through jointed limestones and discharging above erodible layers acts as one of the key agents of erosion.

The lower section of the cliff, along with the upper strata during storm events, is influenced by active wave swash, splash, and spray. In addition to high wave intensity, hydraulic forcing within joints creates conditions favourable to the formation of abrasion notches. In the initial stage, the horizontal cross-section is V-shaped. As the notch deepens, mechanical erosion becomes more evenly distributed, leading to gradual rounding. Evolution is slow, and collapses are absent. Structural notches resulting from differential erosion have formed in the lower section of the Kallavere Fm, where the conglomerate weakens the structure. Talus, accumulated from collapses, provides an effective barrier against wave energy. While fine-grained material is transported seaward, larger boulders are difficult to move, remaining in place for decades. By altering morphometry, these processes feed back into and shape the dynamics that control ongoing development.

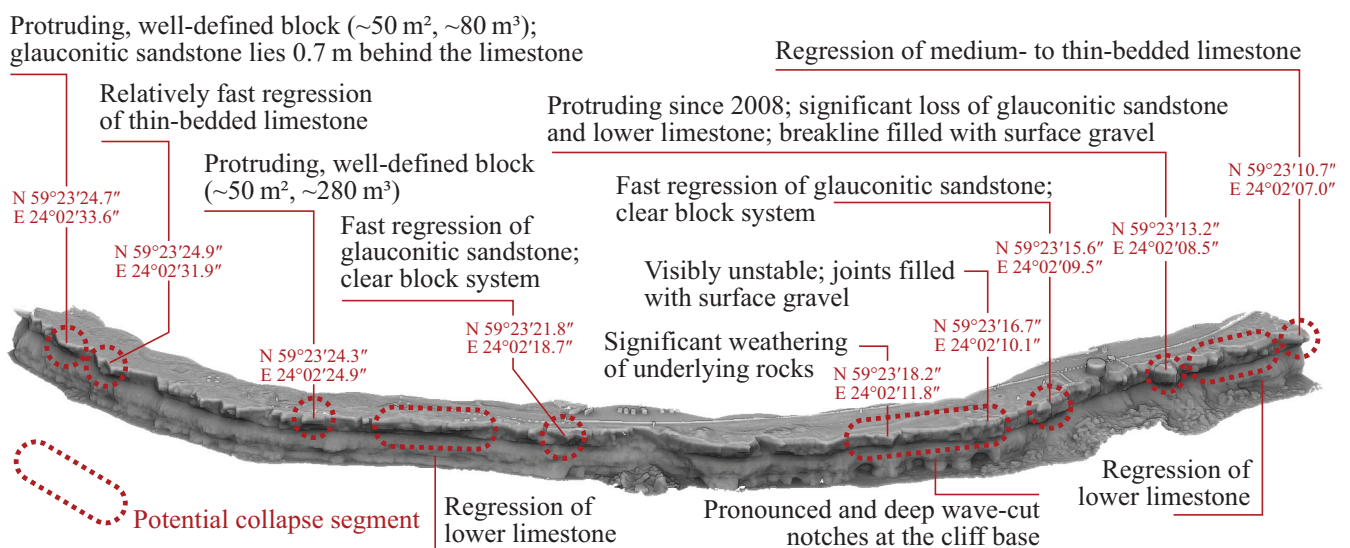
Fig. 13. Potential zones of cliff failure based on the authors' expert opinion.

Geomorphic analysis, together with the evaluation of pre-failure conditions and mechanisms, supports the identification of potential failure zones (Fig. 13). For instance, before major
