## REED ENCROACHMENT ON ESTONIAN BEACHES

Academy of Sciences of the Estonian SSR,  
Institute of Geology

Eric BIRD, Ena MARTIN, Kaarel ORVIKU

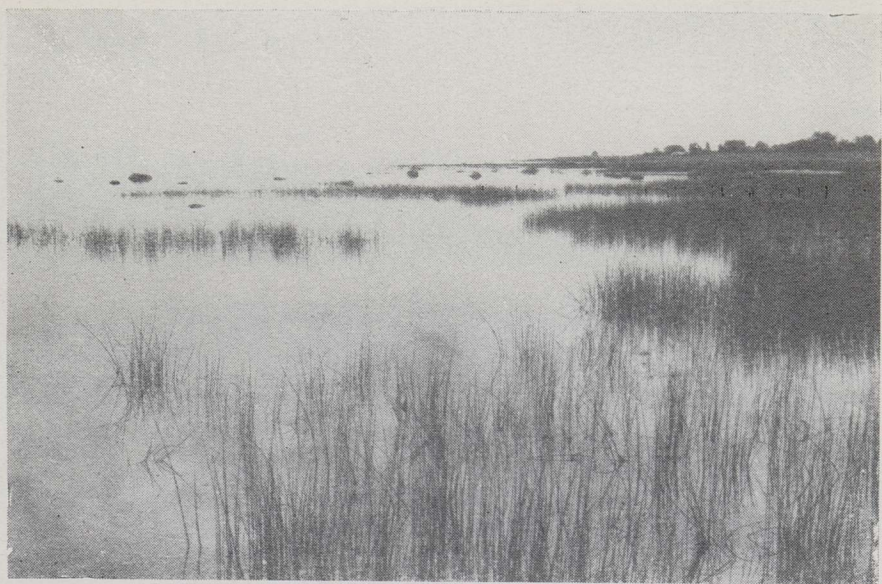
Fig. 2. Reed spread in the eastern part of the Pärnu beach under the effect of waste waters inflow.

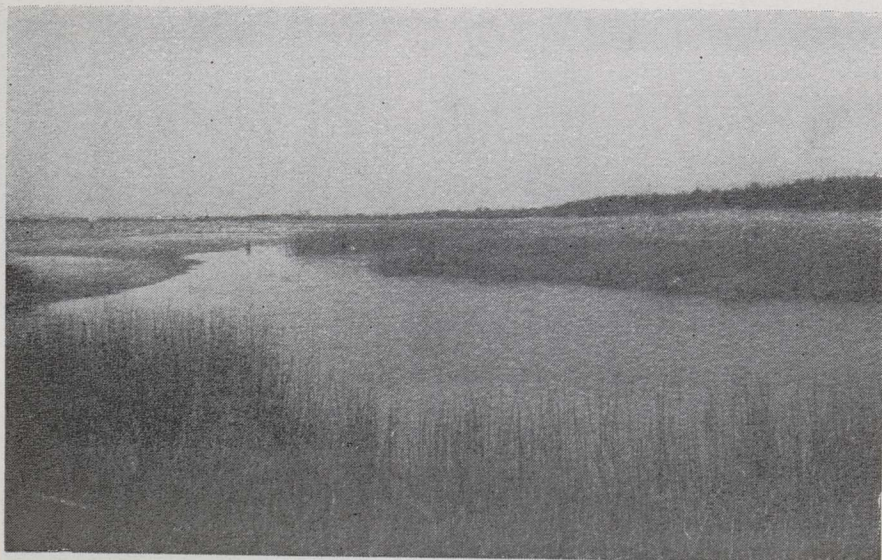
Fig. 3. Beach vegetation has entirely occupied the low southwest coast of Pärnu Bay.

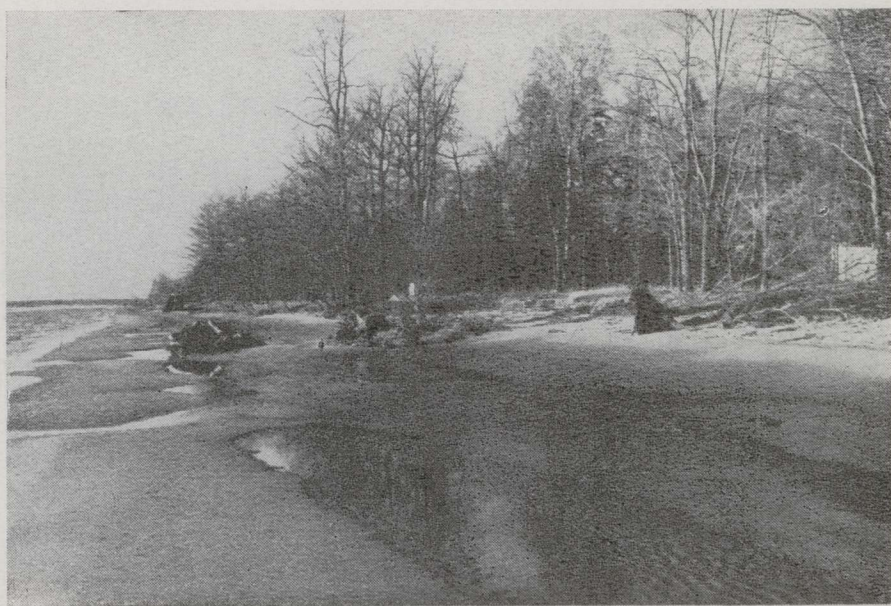
Fig. 5. In the western part of the Valgeranna resort storm damages have intensified in last decades.
