## Development and protection of the coasts in the Tallinn area

**Abstract.** The paper deals with the protection of the coastal areas of Tallinn and their primary development into harbours. The coast and coastal buildings are endangered by strong storm waves, especially in case of a high sea accompanying the storm. Due to the influence of waves, the coastal terrace recedes towards the land; in the bays the sands are whether deposited or swept away. Storms have caused major destruction to the coasts of Aegna Island and the Kakumäe Peninsula. The coastal area owners, the local authorities, and the organs of the state should take measures to protect the coasts through mutual cooperation and improvement of the valid legislation. The coasts and harbours within the boundaries of Tallinn are predominantly state-owned. In planning the development of the harbours it is necessary to reckon with the increase in passenger transport and sea tourism, environmental protection, safety and economic interests of the city, which have so far been somewhat neglected. Tallinn Municipality has begun to rearrange the administration of the coasts and harbours located within the city borders. Muuga Harbou

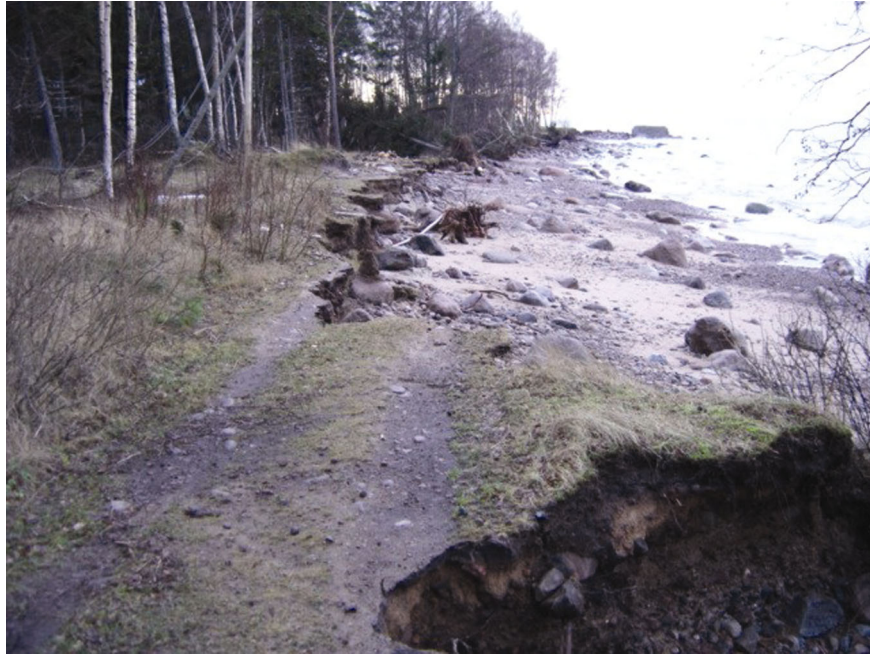
**Fig. 2.** The damage to the Aegna Island coast after the storm in January 2005 (Photo by H. Udusaar).

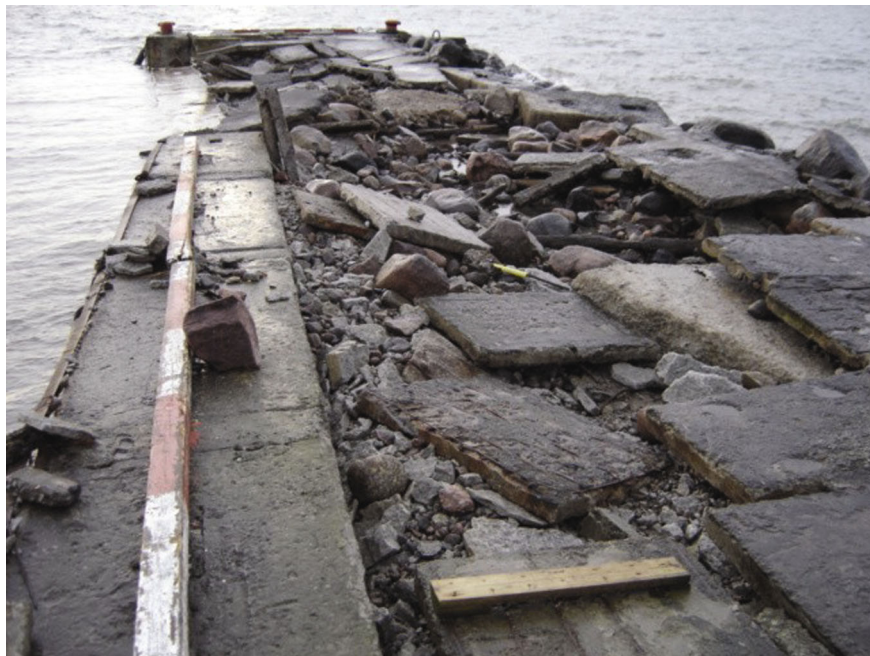
**Fig. 3.** The damage caused to Aegna Harbour by the storm in January 2005 (Photo by H. Udusaar).

4. The care and protection of Aegna Island and the restoration of Aegna Harbour. Aegna used to be a popular place for resting and a region of summer cottages. In the meantime the use of the island decreased drastically and both its coasts and the harbour were damaged by the storms. In the recent years the harbour was restored and the causes of coastal damage and the possibilities for the protection of the coasts were investigated (Orviku 2000). The storm of January 2005 hit Aegna, its coasts and harbour severely. The present task is to make the island again fit for use and open it to the inhabitants of Tallinn as a proper resting place. In future the harbour has to be reconstructed and made stronger and safer.

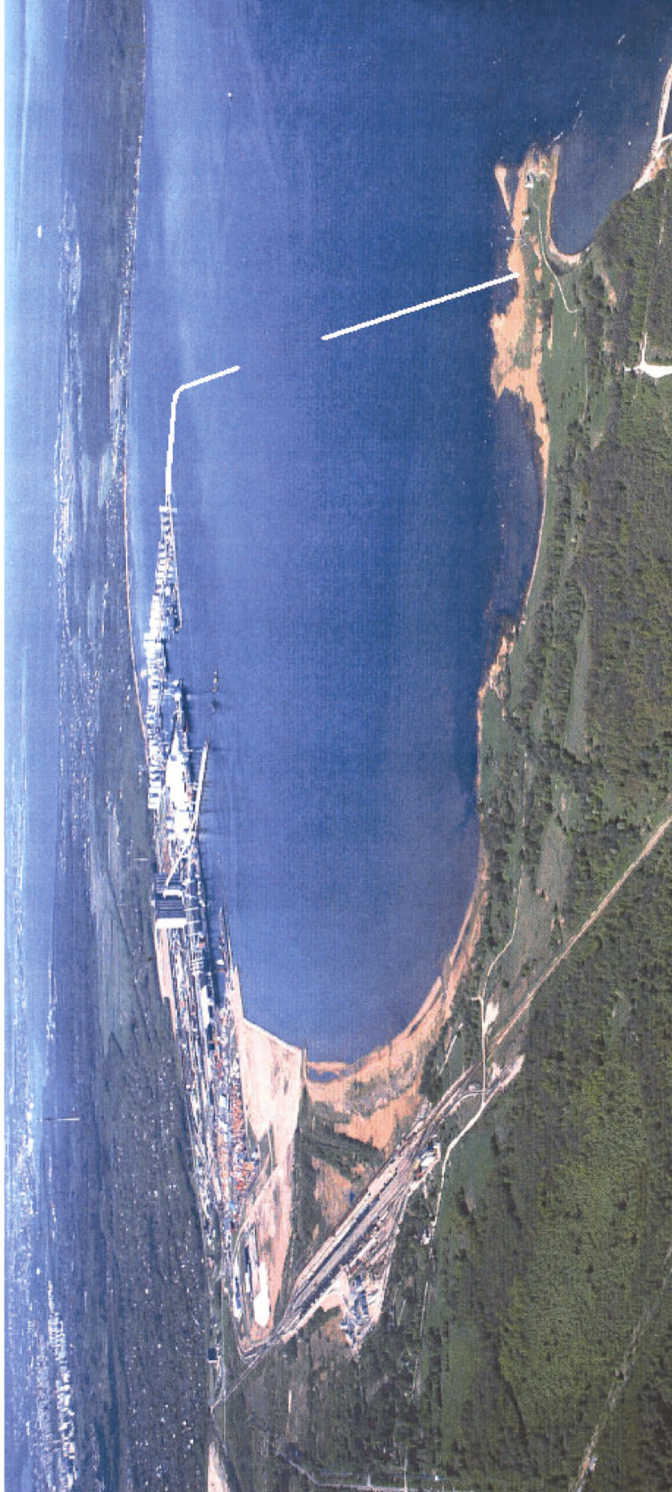
**Fig. 4.** Perspective vision of Muuga Harbour breakwaters.

However, the realization of the possibilities of Muuga Harbour and the expansion of its activities are hindered by the absence of the indispensable breakwaters. The breakwaters were already originally planned for the harbour, but have remained unbuilt thus far. One of the possible locations of breakwaters in Muuga Harbour is depicted in Fig. 4.
